IBM System Storage SAN Volume Controller

Troubleshooting Guide

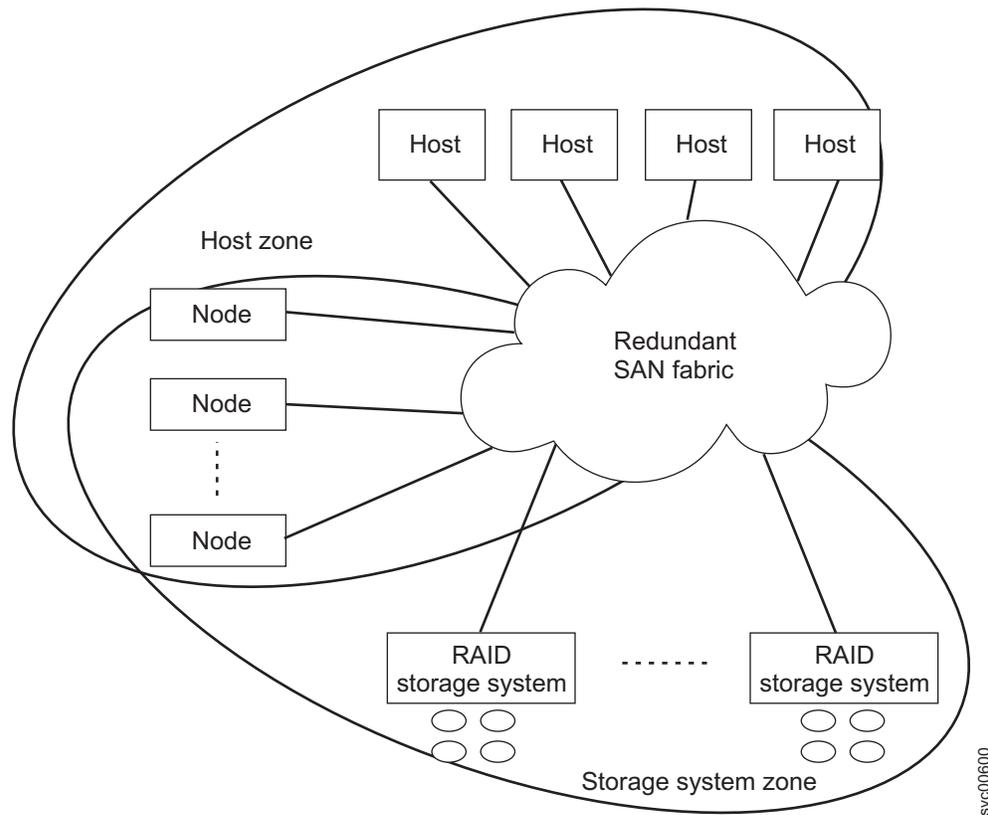
Figure 1 shows hosts, SAN Volume Controller nodes, and RAID storage systems connected to a SAN fabric. The redundant SAN fabric comprises a fault-tolerant arrangement of two or more counterpart SANs that provide alternative paths for each SAN-attached device.

Figure 1. SAN Volume Controller system in a fabric

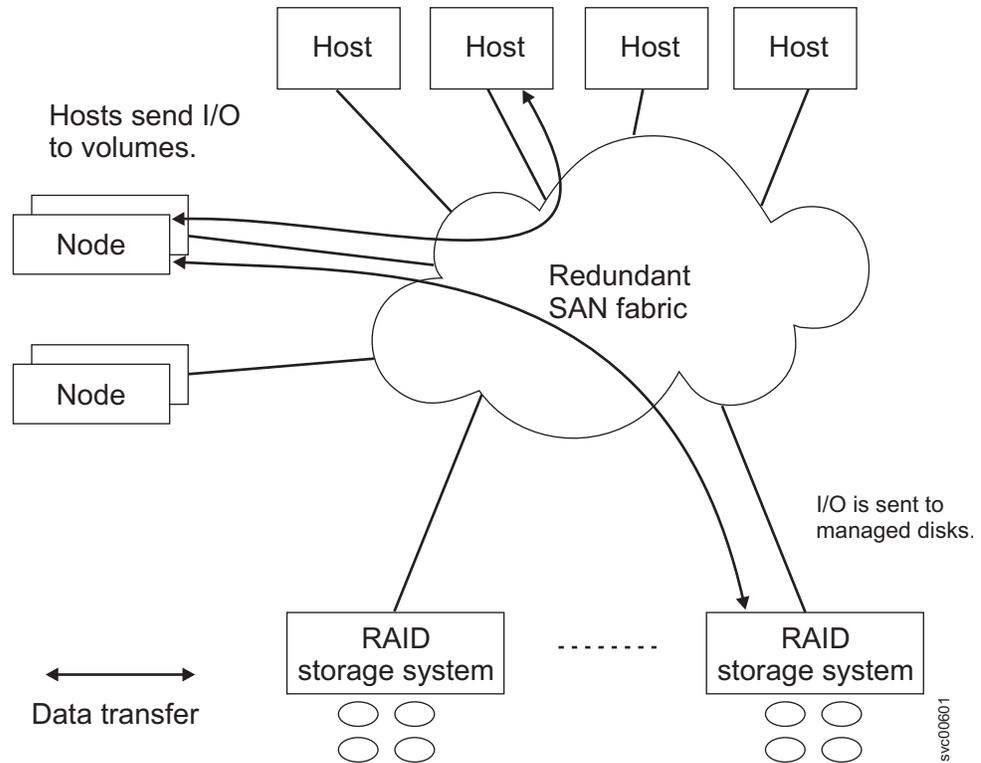
Figure 2 on page 3 shows the data flow across the fabric.

Figure 2. Data flow in a SAN Volume Controller system

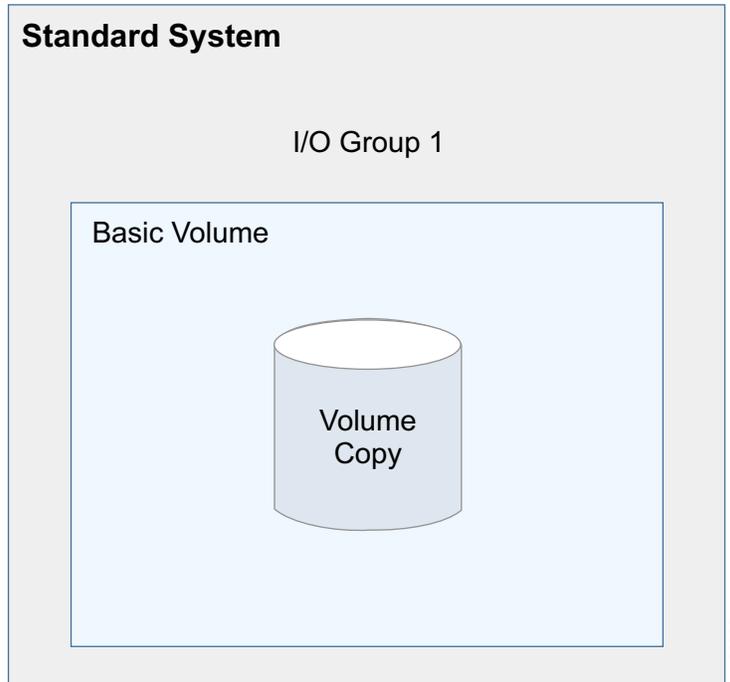
- *Basic volumes*, where a single copy of the volume is cached in one I/O group. Basic volumes can be established in any system topology; however, Figure 3 on page 4 shows a standard system topology.

Figure 3. Example of a basic volume

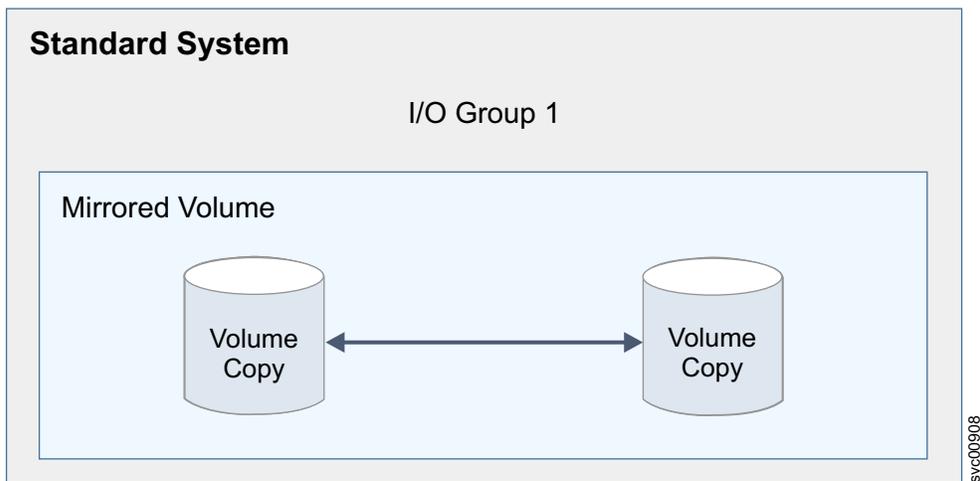
- *Mirrored volumes*, where copies of the volume can either be in the same storage pool or in different storage pools. The volume is cached in a single I/O group. Typically, mirrored volumes are established in a standard system topology.

Figure 4. Example of mirrored volumes

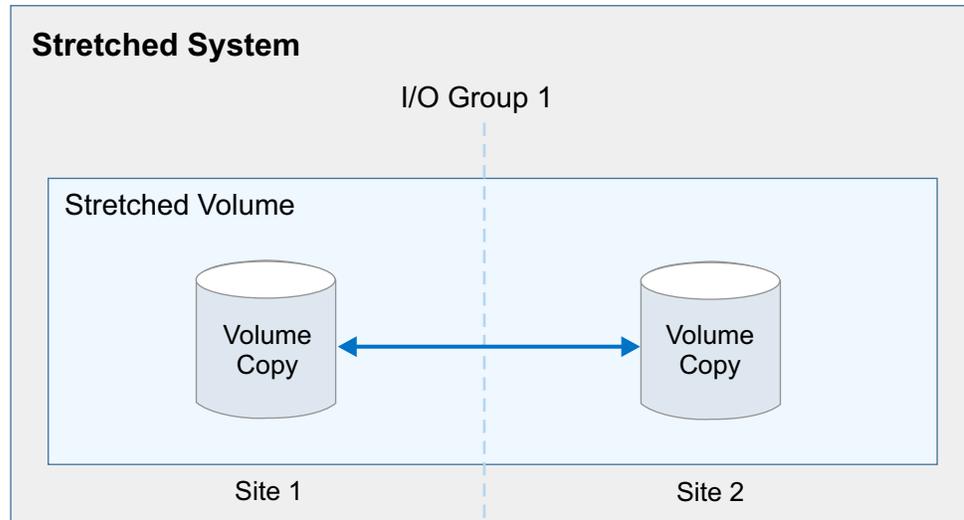
- *Stretched volumes*, where copies of a single volume are in different storage pools at different sites. The volume is cached in one I/O group. Stretched volumes are only available in stretched topology systems.

Figure 5. Example of stretched volumes

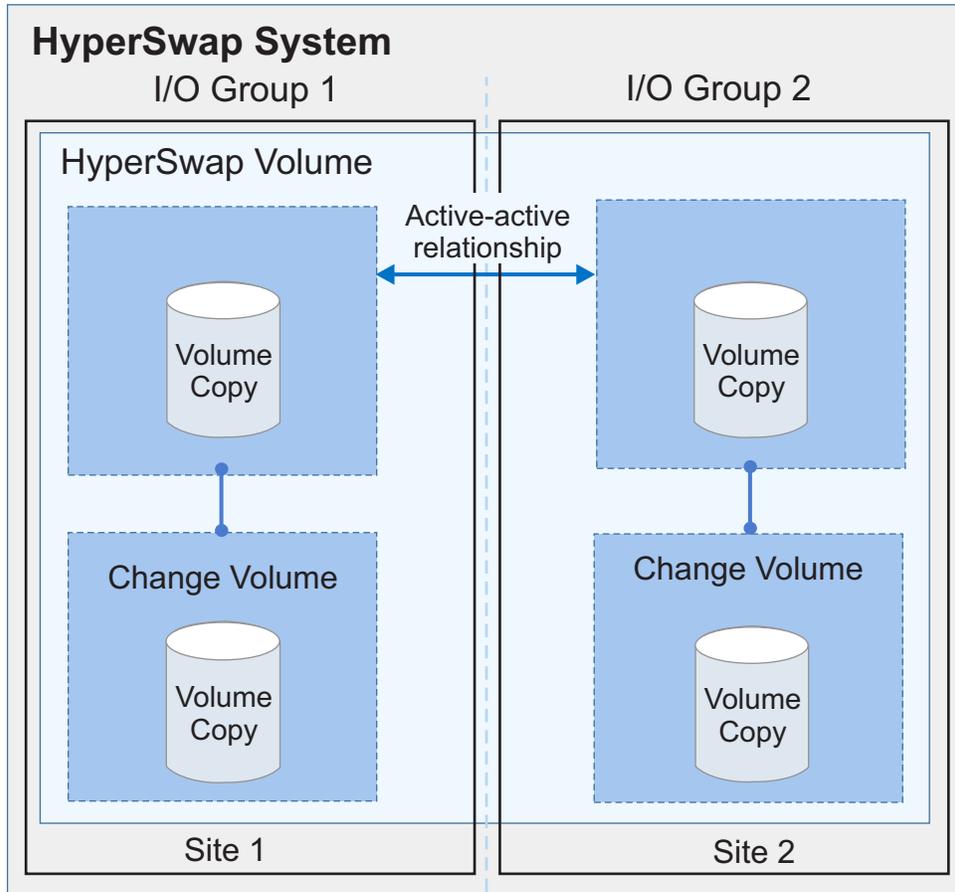
- *HyperSwap volumes*, where copies of a single volume are in different storage pools that are on different sites. The volume is cached in two I/O groups that are on different sites. These volumes can be created only when the system topology is HyperSwap.

Figure 6. Example of HyperSwap volumes

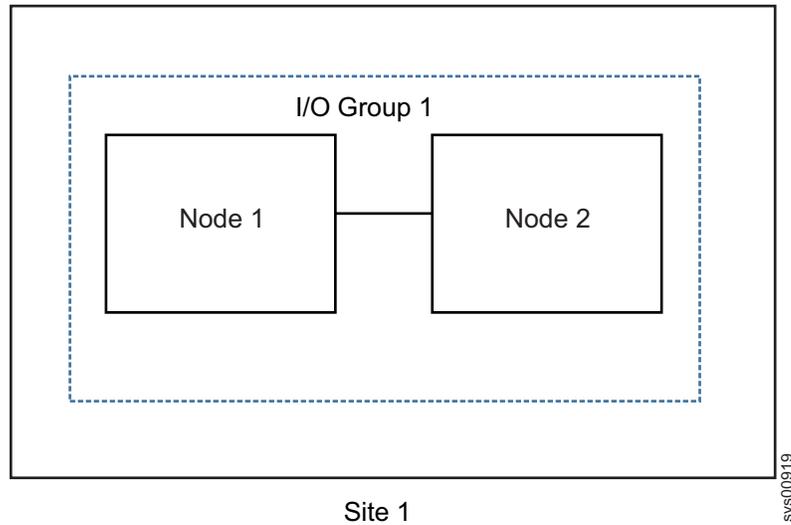
- *Standard* topology, where all nodes in the system are at the same site.

Figure 7. Example of a standard system topology

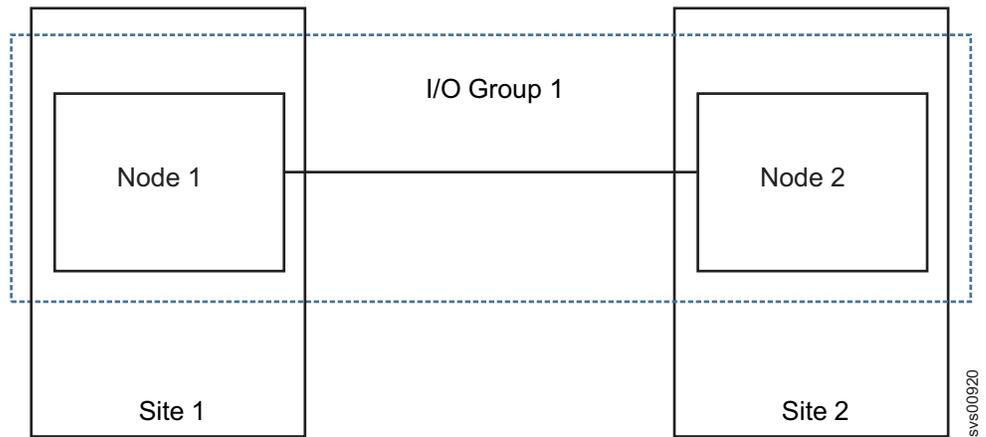
- *Stretched* topology, where each node of an I/O group is at a different site. When one site is not available, access to a volume can continue but with reduced performance.

Figure 8. Example of a stretched system topology

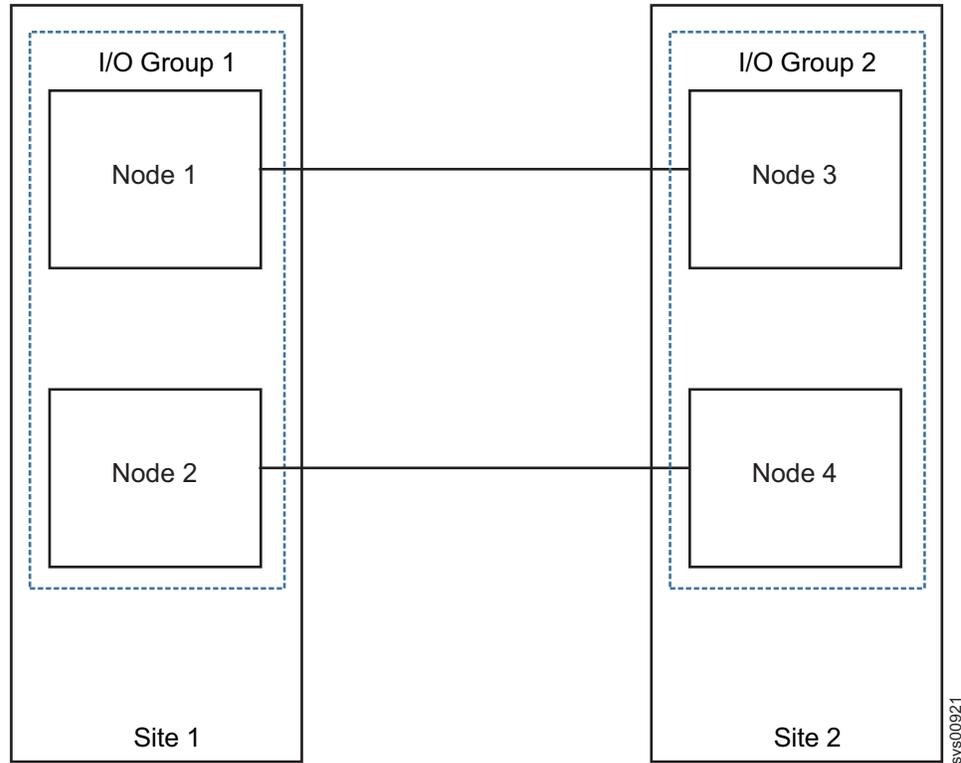
- *HyperSwap* topology, where the system consists of at least two I/O groups. Each I/O group is at a different site. Both nodes of an I/O group are at the same site. A volume can be active on two I/O groups so that it can immediately be accessed by the other site when a site is not available.

Figure 9. Example of a HyperSwap system topology

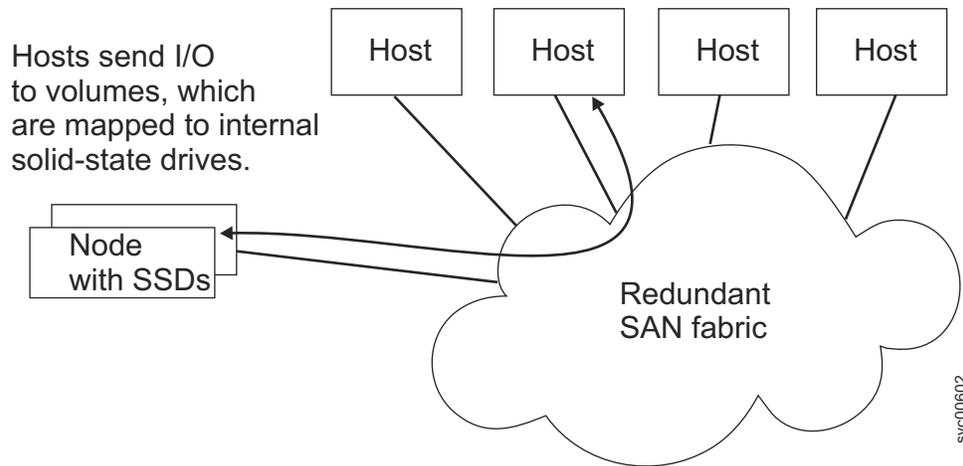
Flash drives provide host servers with a pool of high-performance storage for critical applications. Figure 10 on page 10 shows this configuration. MDisks on flash drives can also be placed in a storage pool with MDisks from regular RAID storage systems. IBM Easy Tier performs automatic data placement within that storage pool by moving high-activity data onto better-performing storage.

Figure 10. SAN Volume Controller nodes with internal Flash drives

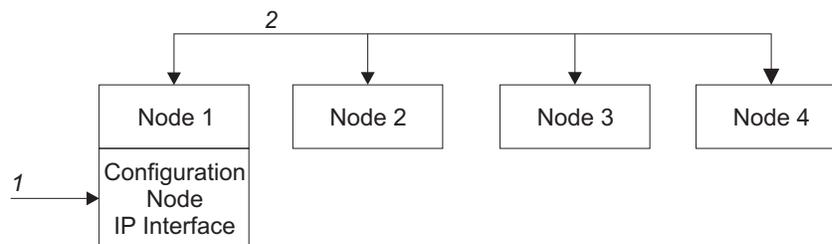
Figure 11 shows an example of a clustered system that contains four nodes. Node 1 is the configuration node. User requests (**1**) are handled by node 1.

Figure 11. SAN Volume Controller configuration node

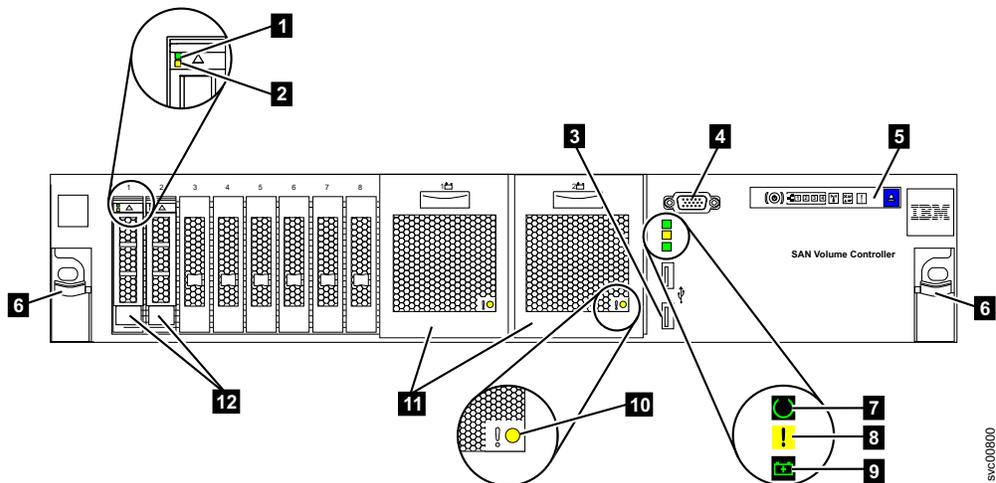
Figure 12 on page 18 shows the controls and indicators on the front panel of the SAN Volume Controller 2145-DH8.

Figure 12. SAN Volume Controller 2145-DH8 front panel

- 1** Hard disk drive activity LED
- 2** Hard disk drive status LED
- 3** USB port
- 4** Video connector
- 5** Operator-information panel
- 6** Rack release latch
- 7** Node status LED
- 8** Node fault LED
- 9** Battery status LED
- 10** Battery fault LED
- 11** Batteries
- 12** Hard disk drives (boot drives)

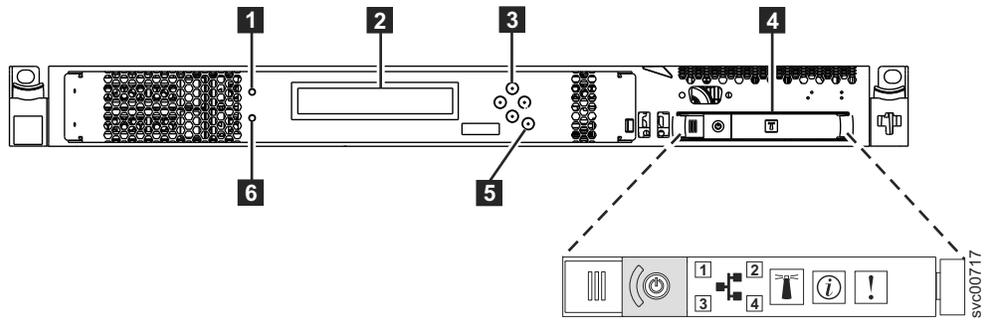
Figure 13 on page 20 shows the controls and indicators on the front panel of the SAN Volume Controller 2145-CG8.

Figure 13. SAN Volume Controller 2145-CG8 front panel

- 1** Node-status LED
- 2** Front-panel display
- 3** Navigation buttons
- 4** Operator-information panel
- 5** Select button
- 6** Error LED

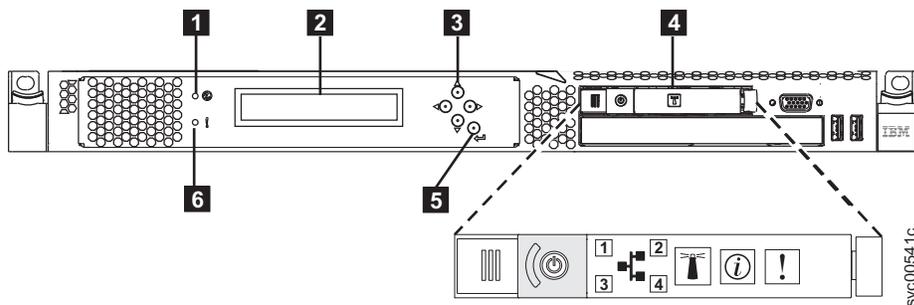
Figure 14 shows the controls and indicators on the front panel of the SAN Volume Controller 2145-CF8.

Figure 14. SAN Volume Controller 2145-CF8 front panel

- 1** Node-status LED
- 2** Front-panel display
- 3** Navigation buttons
- 4** Operator-information panel
- 5** Select button
- 6** Error LED

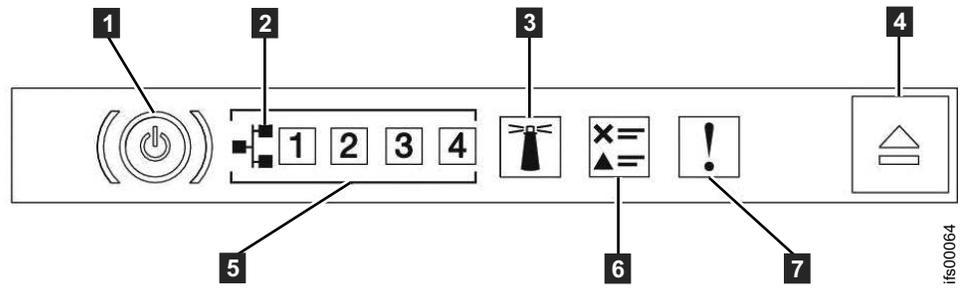
Figure 15 on page 23 shows the operator-information panel for the SAN Volume Controller 2145-DH8.

Figure 15. SAN Volume Controller 2145-DH8 operator information panel

- 1** Power-control button and power-on LED (green)
- 2** Ethernet icon
- 3** System-locator button and LED (blue)
- 4** Release latch for the light path diagnostics panel
- 5** Ethernet activity LEDs
- 6** Check log LED
- 7** System-error LED (yellow)

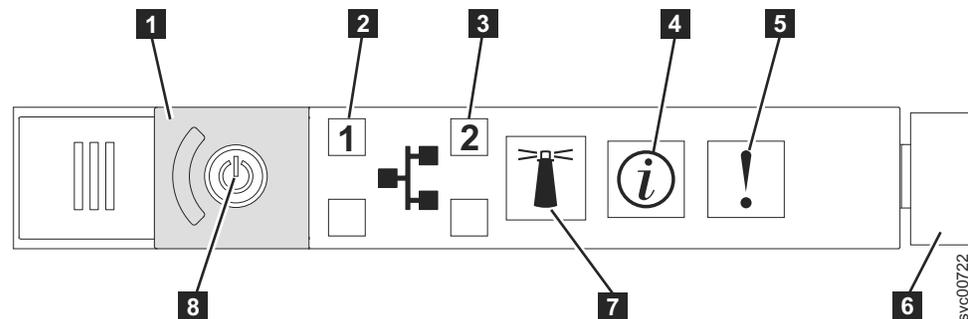
Figure 16 shows the operator-information panel for the SAN Volume Controller 2145-CG8.

Figure 16. SAN Volume Controller 2145-CG8 or 2145-CF8 operator-information panel

- 1** Power-button cover
- 2** Ethernet 1 activity LED. The operator-information panel LEDs refer to the Ethernet ports that are mounted on the system board.
- 3** Ethernet 2 activity LED. The operator-information panel LEDs refer to the Ethernet ports that are mounted on the system board.
- 4** System-information LED
- 5** System-error LED
- 6** Release latch
- 7** Locator button and LED

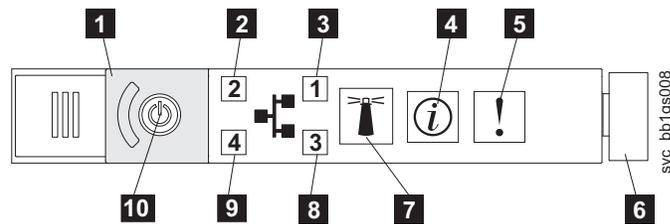
Figure 17 shows the operator-information panel for the SAN Volume Controller 2145-CF8.

Figure 17. SAN Volume Controller 2145-CG8 or 2145-CF8 operator-information panel

- 1 Power-button cover
- 2 Ethernet 2 activity LED
- 3 Ethernet 1 activity LED
- 4 System-information LED
- 5 System-error LED
- 6 Release latch
- 7 Locator button and LED
- 8 Not used
- 9 Not used
- 10 Power button and LED

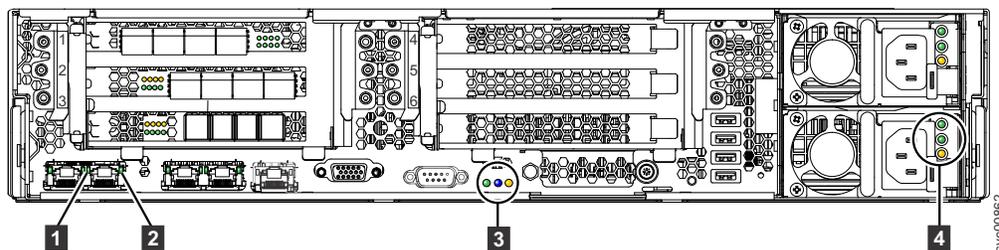
Figure 18 shows the rear-panel indicators on the SAN Volume Controller 2145-DH8 back-panel assembly.

Figure 18. SAN Volume Controller 2145-DH8 rear-panel indicators

- 1** Ethernet-link LED
- 2** Ethernet-activity LED
- 3** Power, location, and system-error LEDs
- 4** AC, DC, and power-supply error LEDs

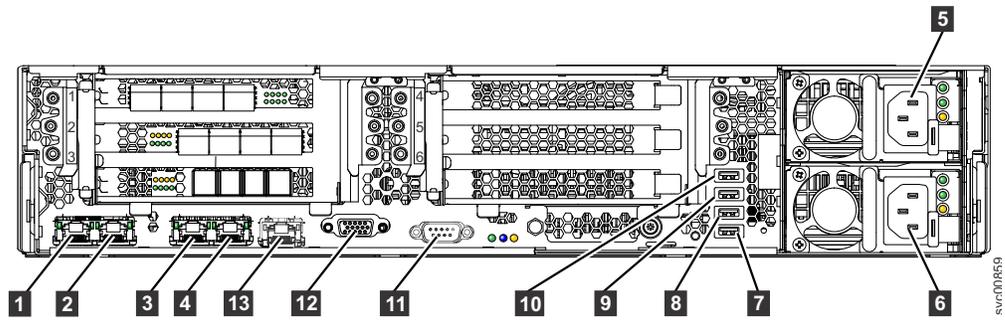
Figure 19 on page 27 shows the external connectors on the SAN Volume Controller 2145-DH8 back panel assembly.

Figure 19. Connectors on the rear of the SAN Volume Controller 2145-DH8

- 1** 1 Gbps Ethernet port 1
- 2** 1 Gbps Ethernet port 2
- 3** 1 Gbps Ethernet port 3
- 4** Technician port (Ethernet)
- 5** Power supply 2
- 6** Power supply 1
- 7** USB 6
- 8** USB 5
- 9** USB 4
- 10** USB 3
- 11** Serial
- 12** Video
- 13** Unused Ethernet port

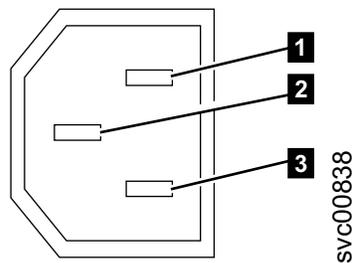
Figure 20 shows the type of connector that is located on each power-supply assembly.

Figure 20. Power connector

- 1** Neutral
- 2** Ground
- 3** Live

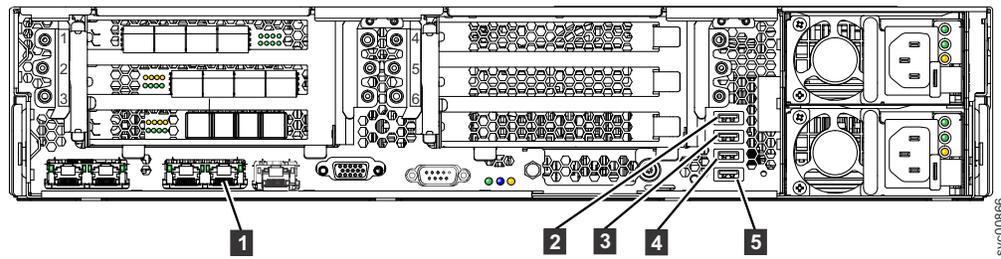
Figure 21 shows ports that are used only during service procedures.

Figure 21. SAN Volume Controller 2145-DH8 service ports

- 1** Technician port (Ethernet)
- 2** USB 3
- 3** USB 4
- 4** USB 5
- 5** USB 6

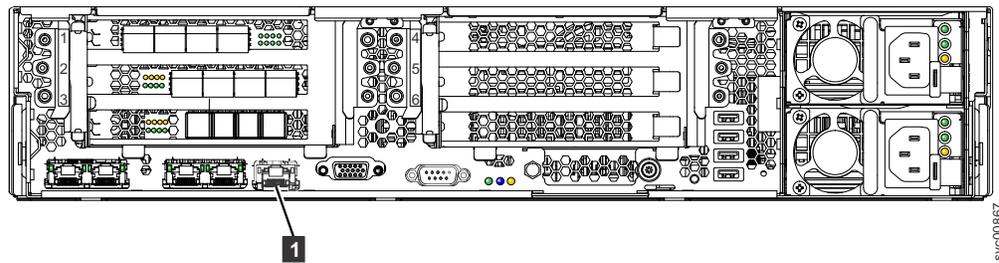
Figure 22 shows the one port that is not used during service procedures or normal operation. This port is disabled in software to make the port inactive.

Figure 22. SAN Volume Controller 2145-DH8 unused Ethernet port

- 1** Unused Ethernet port

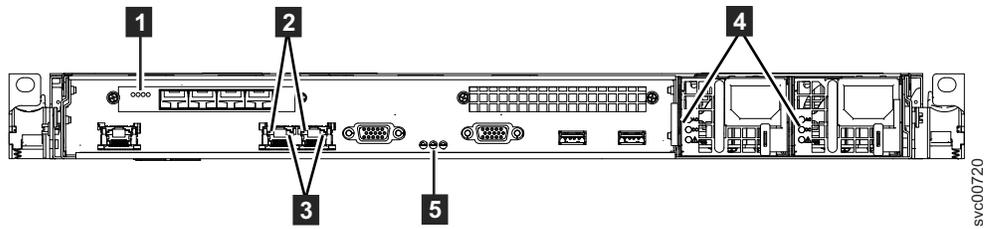
Figure 23 on page 29 shows the rear-panel indicators on the SAN Volume Controller 2145-CG8 back-panel assembly.

Figure 23. SAN Volume Controller 2145-CG8 rear-panel indicators

- 1** Fibre Channel LEDs
- 2** Ethernet-link LEDs
- 3** Ethernet-activity LEDs
- 4** Ac, dc, and power-supply error LEDs
- 5** Power, location, and system-error LEDs

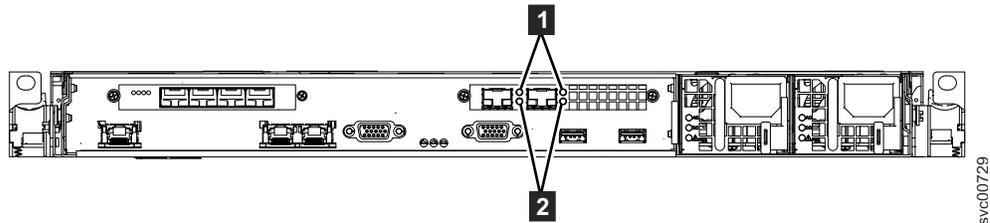
Figure 24 shows the rear-panel indicators on the SAN Volume Controller 2145-CG8 back-panel assembly that has the 10 Gbps Ethernet feature.

Figure 24. SAN Volume Controller 2145-CG8 rear-panel indicators for the 10 Gbps Ethernet feature

- 1** 10 Gbps Ethernet-link LEDs. The amber link LED is on when this port is connected to a 10 Gbps Ethernet switch and the link is online.
- 2** 10 Gbps Ethernet-activity LEDs. The green activity LED is on while data is being sent over the link.

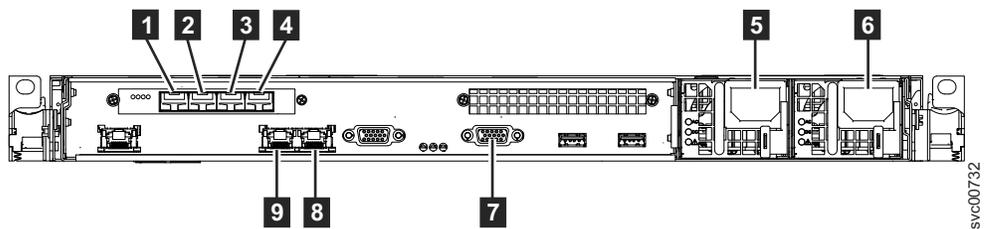
These figures show the external connectors on the SAN Volume Controller 2145-CG8 back panel assembly.

Figure 25. Connectors on the rear of the SAN Volume Controller 2145-CG8

- 1** Fibre Channel port 1
- 2** Fibre Channel port 2
- 3** Fibre Channel port 3
- 4** Fibre Channel port 4
- 5** Power cord connector for power supply 1
- 6** Power cord connector for power supply 2
- 7** Serial connection for UPS communication cable
- 8** Ethernet port 2
- 9** Ethernet port 1

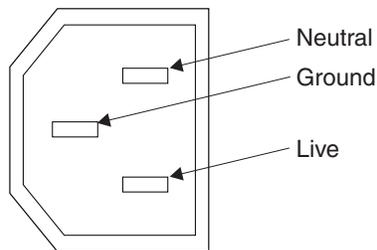
Figure 27 shows the type of connector that is located on each power-supply assembly. Use these connectors to connect the SAN Volume Controller 2145-CG8 to the two power cables from the uninterruptible power supply.

Figure 27. Power connector

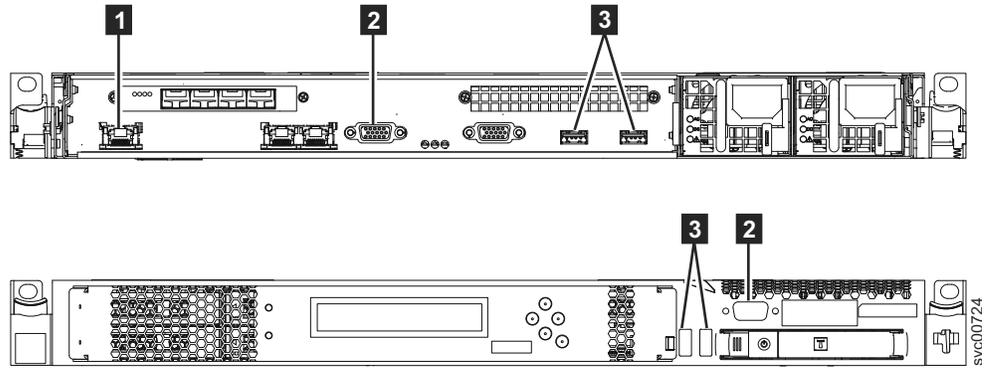
Figure 28 on page 31 shows ports that are used only during service procedures.

Figure 28. Service ports of the SAN Volume Controller 2145-CG8

- 1** System management port
- 2** Two monitor ports, one on the front and one on the rear
- 3** Four USB ports, two on the front and two on the rear

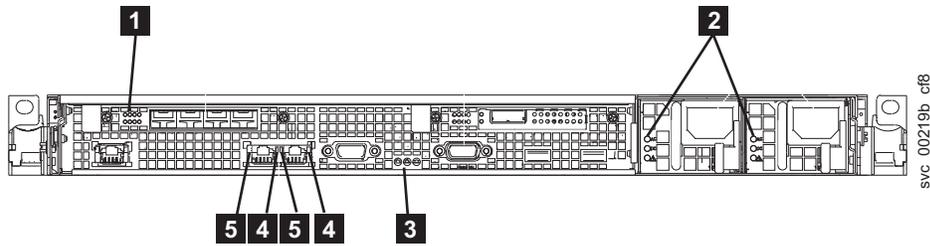
Figure 30 on page 32 shows the rear-panel indicators on the SAN Volume Controller 2145-CF8 back-panel assembly.

Figure 30. SAN Volume Controller 2145-CF8 rear-panel indicators

- 1** Fibre Channel LEDs
- 2** AC, DC, and power-supply error LEDs
- 3** Power, location, and system-error LEDs
- 4** Ethernet-link LEDs
- 5** Ethernet-activity LEDs

The rear-panel indicators consist of LEDs that indicate the status of the Fibre Channel ports, Ethernet connection and activity, power, electrical current, and system-board errors.

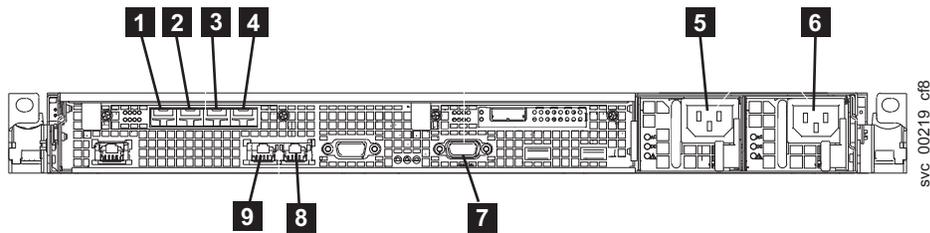
External connectors that the SAN Volume Controller 2145-CF8 uses include four Fibre Channel ports, a serial port, two Ethernet ports, and two power connectors.

Figure 31 shows the external connectors on the SAN Volume Controller 2145-CF8 back panel assembly.

Figure 31. Connectors on the rear of the SAN Volume Controller 2145-CG8 or 2145-CF8

- 1** Fibre Channel port 1
- 2** Fibre Channel port 2
- 3** Fibre Channel port 3
- 4** Fibre Channel port 4
- 5** Power cord connector for power supply 1
- 6** Power cord connector for power supply 2
- 7** Serial connection for UPS communication cable
- 8** Ethernet port 2
- 9** Ethernet port 1

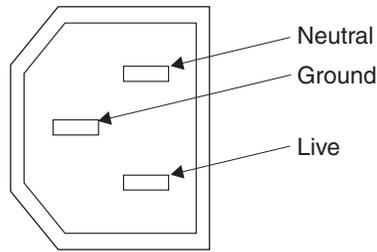
Figure 32 on page 33 shows the type of connector that is located on each power-supply assembly. Use these connectors to connect the SAN Volume Controller 2145-CF8 to the two power cables from the uninterruptible power supply.

Figure 32. Power connector

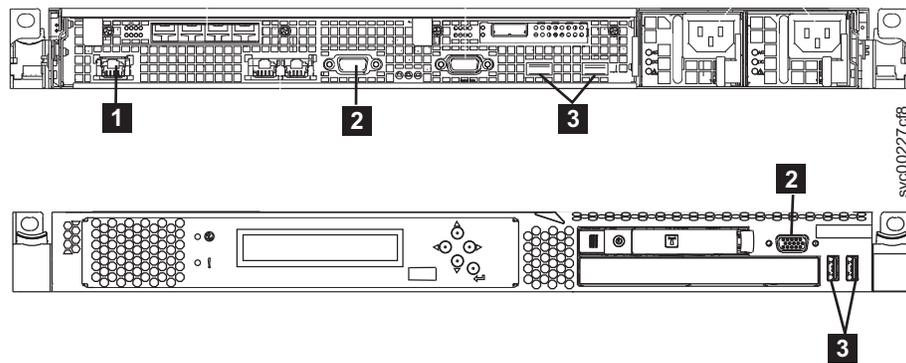
Figure 33 shows ports that are used only during service procedures.

Figure 33. Service ports of the SAN Volume Controller 2145-CF8

- 1** System management port
- 2** Two monitor ports, one on the front and one on the rear
- 3** Four USB ports, two on the front and two on the rear

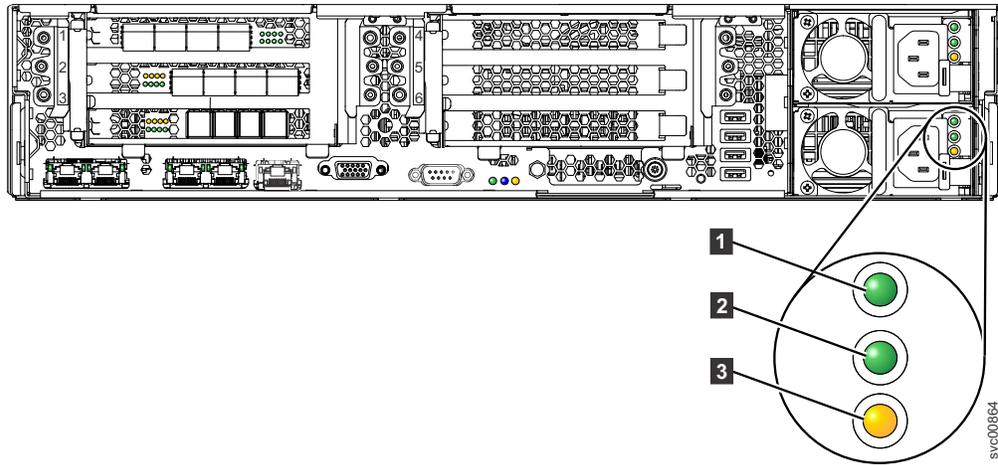
Figure 35 on page 36 shows the location of the SAN Volume Controller 2145-DH8 AC, DC, and power-supply error LEDs.

Figure 35. SAN Volume Controller 2145-DH8 AC, DC, and power-error LEDs

Each of the two power supplies has its own set of LEDs.

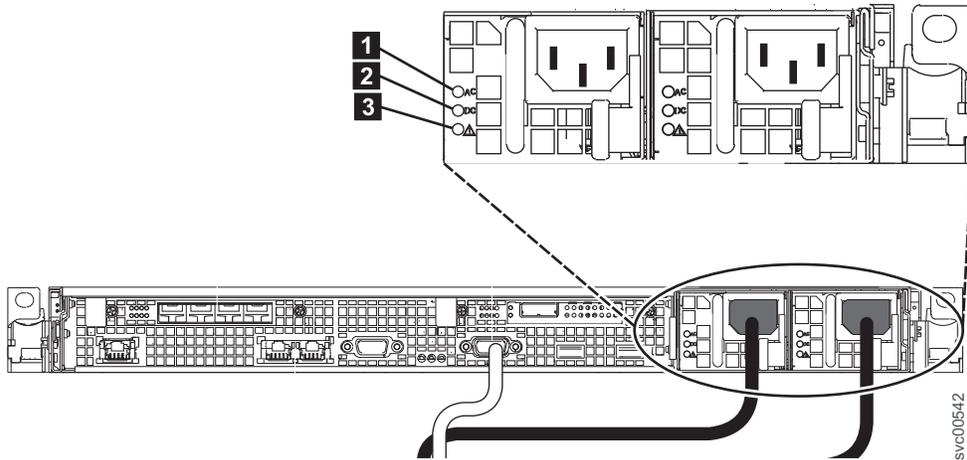
Figure 36 shows the location of the AC, DC, and power-supply error LEDs.

Figure 36. SAN Volume Controller 2145-CG8 or 2145-CF8 AC, DC, and power-error LEDs

Each of the two power supplies has its own set of LEDs.

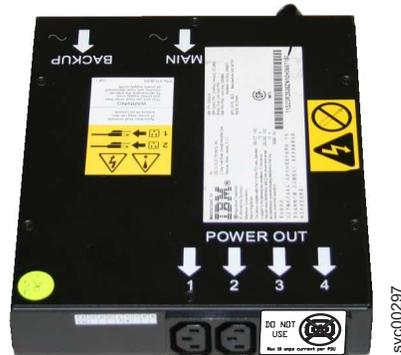
Figure 37 shows a redundant AC-power switch.

Figure 37. Photo of the redundant AC-power switch

The redundant AC-power switch is an optional feature that makes the SAN Volume Controller nodes resilient to the failure of a single power circuit. The redundant AC-power switch is not a replacement for an uninterruptible power supply. You must still use an uninterruptible power supply for each node.

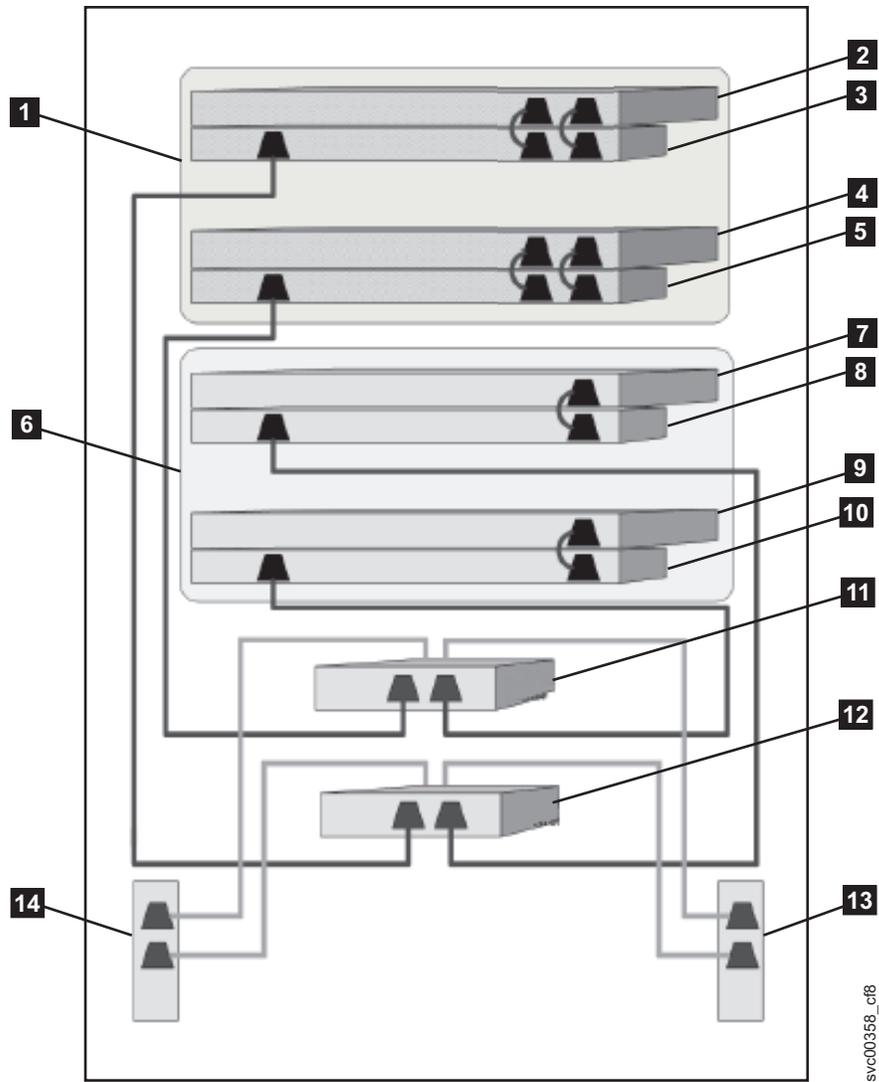
Figure 38 on page 47 shows an example of the main wiring connections for a SAN Volume Controller clustered system with the redundant AC-power switch feature. This example is designed to clearly show the cable connections; the components are not positioned as they would be in a rack. Figure 39 on page 49 shows a typical rack installation. The four-node clustered system consists of two I/O groups:

- I/O group 0 contains nodes A and B
- I/O group 1 contains nodes C and D

Figure 38. A four-node SAN Volume Controller system with the redundant AC-power switch feature

- 1** I/O group 0
- 2** SAN Volume Controller node A
- 3** 2145 UPS-1U A
- 4** SAN Volume Controller node B
- 5** 2145 UPS-1U B
- 6** I/O group 1
- 7** SAN Volume Controller node C
- 8** 2145 UPS-1U C
- 9** SAN Volume Controller node D
- 10** 2145 UPS-1U D
- 11** Redundant AC-power switch 1
- 12** Redundant AC-power switch 2
- 13** Site PDU X (C13 outlets)
- 14** Site PDU Y (C13 outlets)

Some SAN Volume Controller node types have two power supply units. Both power supplies must be connected to the same 2145 UPS-1U, as shown by node A and node B. The SAN Volume Controller 2145-CG8 is an example of a node that has two power supplies.

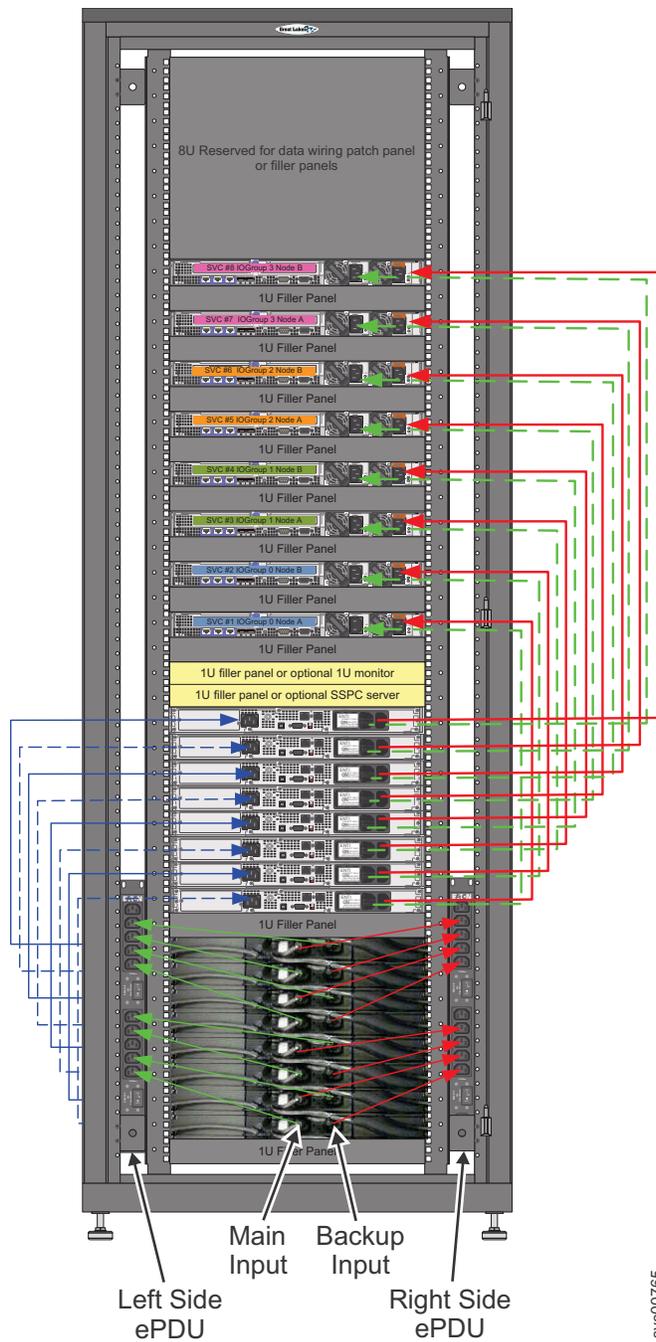
Figure 39 on page 49 shows an 8 node cluster, with one redundant ac-power switch per node installed in a rack using best location practices, the cables between the components are shown.

Figure 39. Rack cabling example.

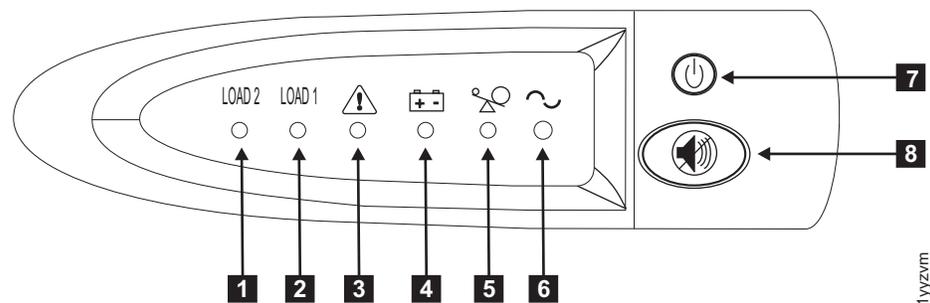
All controls and indicators for the 2145 UPS-1U are located on the front-panel assembly.

Figure 40. 2145 UPS-1U front-panel assembly

- 1** Load segment 2 indicator
- 2** Load segment 1 indicator
- 3** Alarm or service indicator
- 4** On-battery indicator
- 5** Overload indicator
- 6** Power-on indicator
- 7** On/off button
- 8** Test and alarm reset button

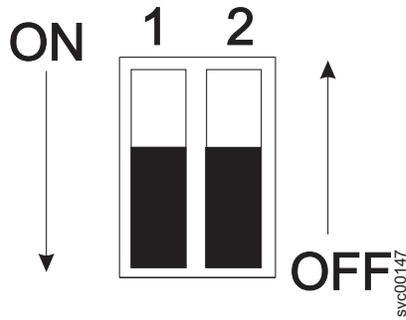
Figure 42 on page 54 shows the dip switches, which can be used to configure the input and output voltage ranges. Because this function is performed by the SAN Volume Controller software, both switches must be left in the OFF position.

Figure 42. 2145 UPS-1U dip switches

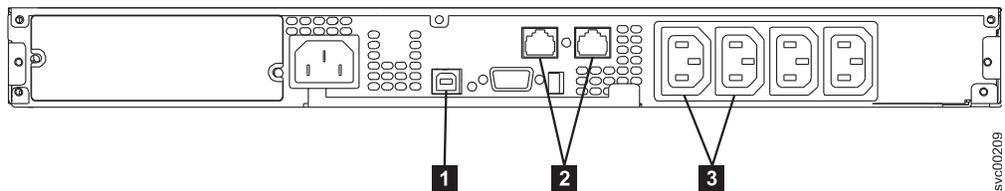
The 2145 UPS-1U is equipped with ports that are not used by the SAN Volume Controller and have not been tested. Use of these ports, in conjunction with the SAN Volume Controller or any other application that might be used with the SAN Volume Controller, is not supported. Figure 43 shows the 2145 UPS-1U ports that are not used.

Figure 43. Ports not used by the 2145 UPS-1U

- 1** USB interface port
- 2** Network ports
- 3** Load segment receptacles

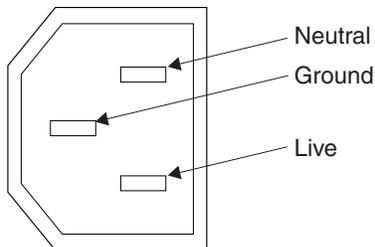
Figure 44 shows the power connector for the 2145 UPS-1U.

Figure 44. Power connector

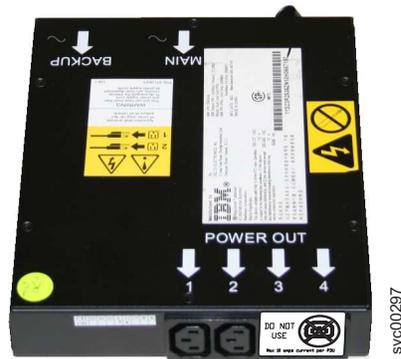
There is a single field-replaceable unit (FRU) assembly for the redundant AC power feature. It consists of the switch and two input-power cables.

Figure 45 shows the redundant AC-power switch.

Figure 45. View of the redundant AC-power switch FRU

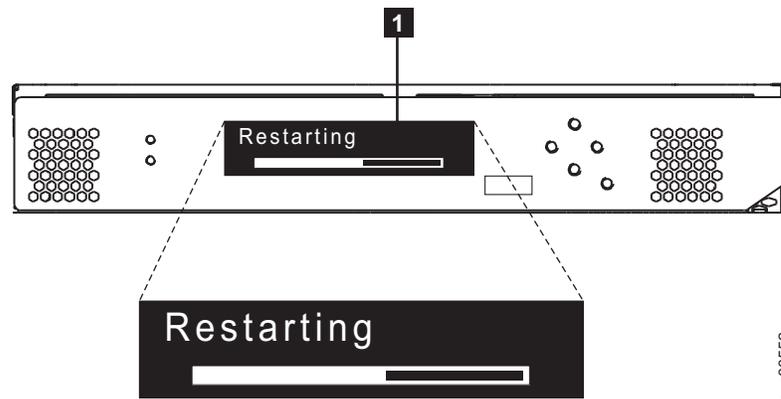
Figure 46 shows where the front-panel display **1** is on the SAN Volume Controller node.

Figure 46. SAN Volume Controller front-panel assembly

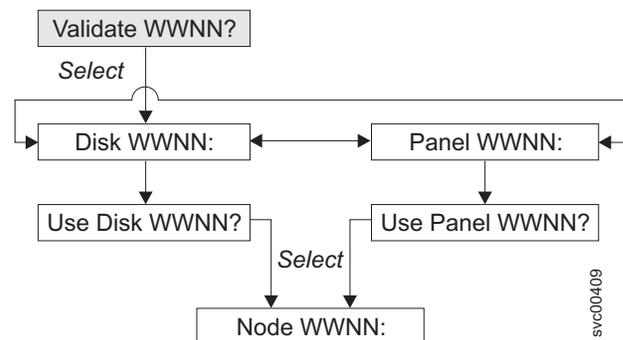
After it is in this mode, the front panel display will not revert to its normal displays, such as node or cluster (system) options or operational status, until the WWNN is validated. Navigate the Validate WWNN option (shown in Figure 51) to choose which WWNN that you want to use.

Figure 51. Validate WWNN? navigation

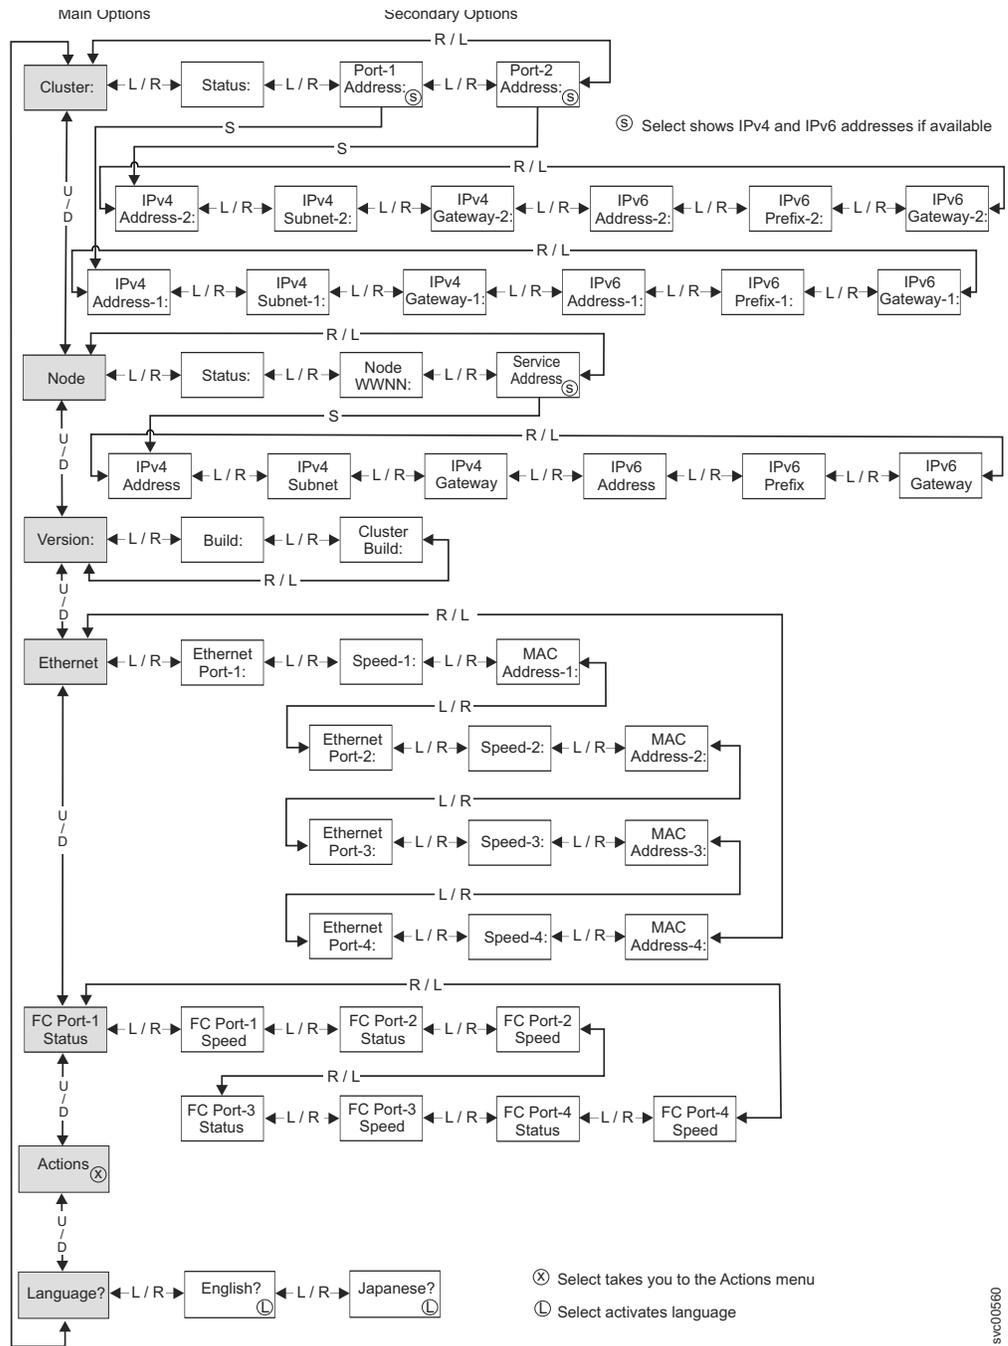
Figure 52 on page 95 shows the sequence of the menu options. Only one option at a time is displayed on the front panel display. For some options, more data is displayed on line 2. The first option that is displayed is the **Cluster:** option.

Figure 52. SAN Volume Controller options on the front-panel display

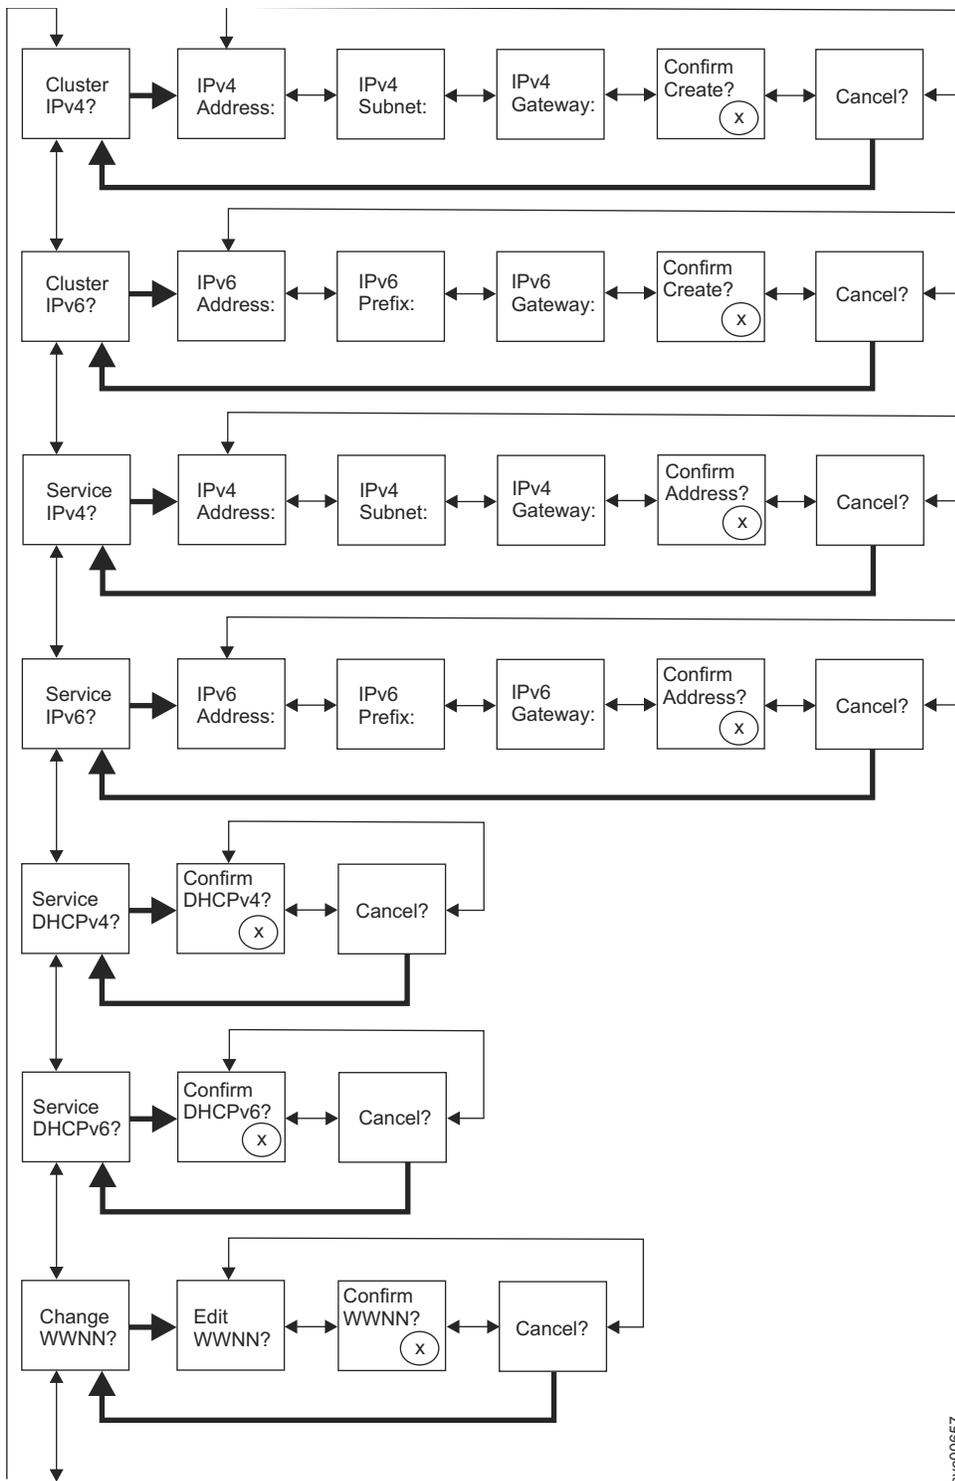
Figure 54. Upper options of the actions menu on the front panel

Figure 54 on page 101, Figure 55 on page 102, and Figure 56 on page 103 show the sequence of the actions options. In the figures, bold lines indicate that the select button was pressed. The lighter lines indicate the navigational path (up or down and left or right). The circled X indicates that if the select button is pressed, an action occurs using the data entered.
