IBM System Storage SAN Volume Controller

Troubleshooting Guide

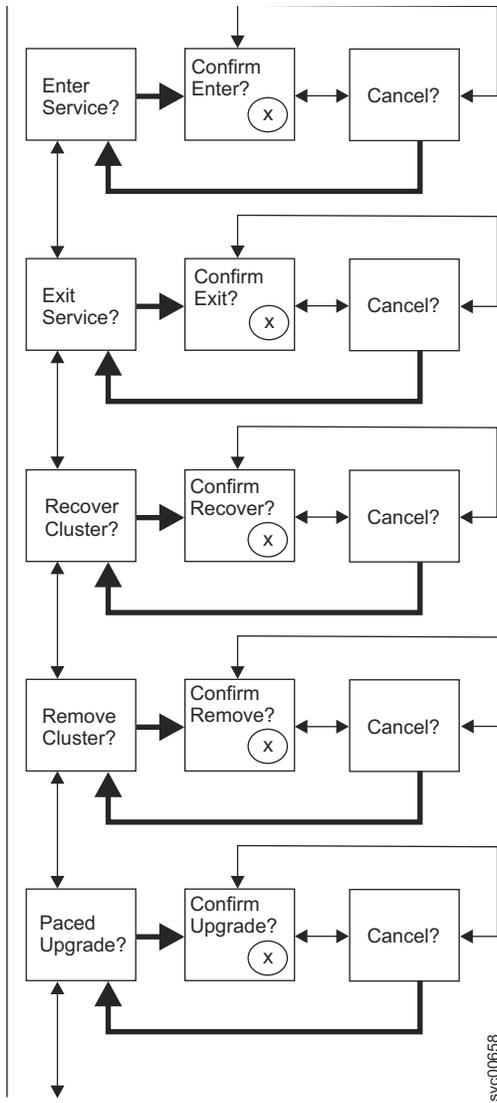
Figure 55. Middle options of the actions menu on the front panel

Figure 54 on page 101, Figure 55 on page 102, and Figure 56 on page 103 show the sequence of the actions options. In the figures, bold lines indicate that the select button was pressed. The lighter lines indicate the navigational path (up or down and left or right). The circled X indicates that if the select button is pressed, an action occurs using the data entered.

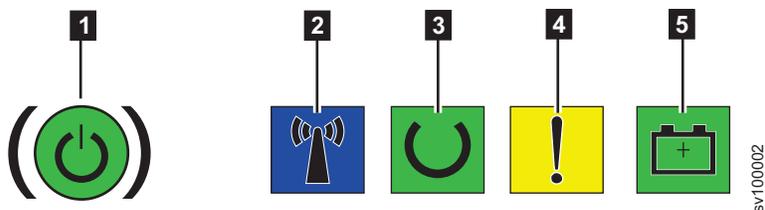
Figure 68 on page 306 shows the operator-information panel for the SAN Volume Controller 2145-SV1.

- 1** Power-control button and power-on LED
- 2** Identify LED
- 3** Node status LED
- 4** Node fault LED
- 5** Battery status LED

Figure 68. SAN Volume Controller 2145-SV1 operator-information panel

Is the operator-information panel error LED (**1 in Figure 67 or **4** in Figure 68 on page 306 or **7** in Figure 69 on page 306) illuminated or flashing? Or, is the check log LED (**6** in Figure 69 on page 306) illuminated or flashing?**

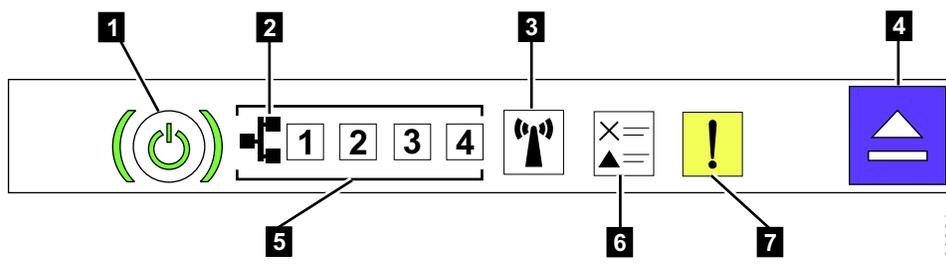
Figure 69 shows the operator-information panel for the SAN Volume Controller 2145-DH8.

- 1** Power-control button and power-on LED
- 2** Ethernet icon
- 3** System-locator button and LED
- 4** Release latch for the light path diagnostics panel
- 5** Ethernet activity LEDs
- 6** Check log LED
- 7** System-error LED

Note: If the node has more than 4 Ethernet ports, activity for ports 5 and above is not indicated by the Ethernet activity LEDs on the operator-information panel.

Figure 69. SAN Volume Controller 2145-DH8 operator-information panel

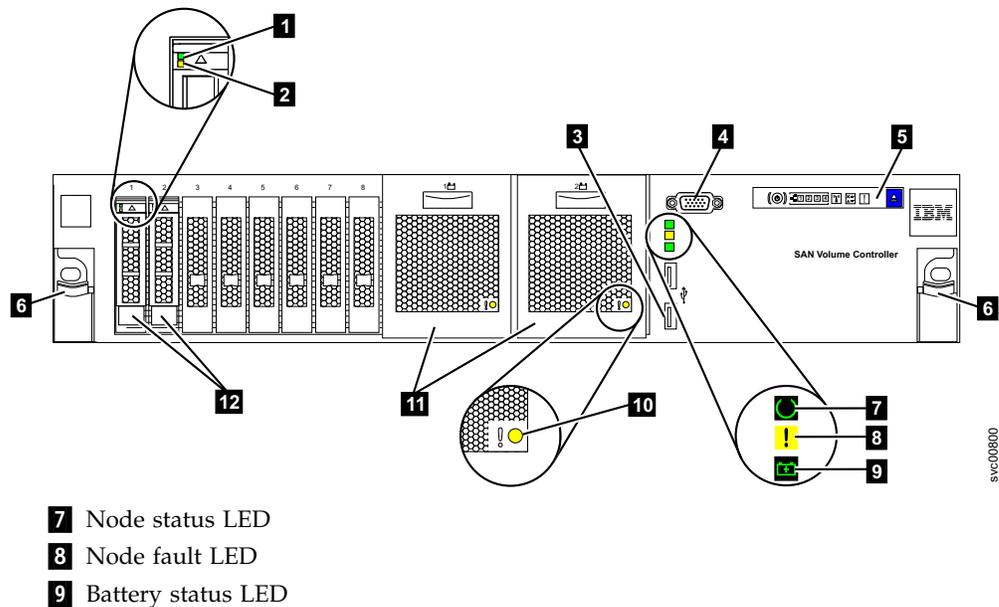
Figure 71. SAN Volume Controller 2145-DH8 front panel

- NO** Go to step 11.
- YES** Go to step 10.
10. (from step 9 on page 306)
- Has the hardware boot display that you see in Figure 70 displayed for more than 3 minutes? For 2145-DH8, have the node status LED, node fault LED, and battery status LED that you see in Figure 71 all been off for more than 3 minutes?**
- NO** Go to step 11.
- YES** For 2145-DH8, go to step 23 on page 311. Otherwise:
- Go to “MAP 5900: Hardware boot” on page 370.
 - Go to “MAP 5700: Repair verification” on page 351.
11. (from step 9 on page 306)
- Is Failed displayed on the top line of the front-panel display of the node?
Or, is the node fault LED (8 in Figure 71) on the front panel of a SAN Volume Controller 2145-DH8 on?**
- Figure 71 shows the node fault LED.

Or, is the node fault LED, which is the middle of the 3 status LEDs on the front panel of a SAN Volume Controller 2145-DH8, on? Figure 71 on page 307 shows the node fault LED.

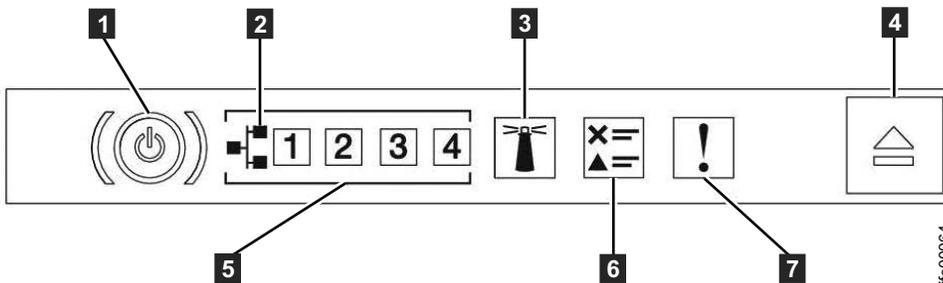
Is the power LED on the operator-information panel continuously illuminated? Figure 72 shows the location of the power LED **1** on the operator-information panel.

1 Power button and power LED (green)

Figure 72. Power LED on the SAN Volume Controller 2145-DH8

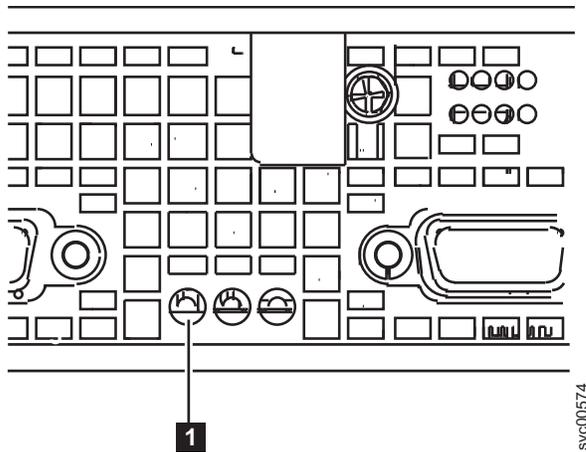
Is the rear panel power LED on or flashing? Figure 73 on page 314 shows the location of the power LED **1** on the SAN Volume Controller 2145-DH8.

Figure 73. Power LED indicator on the rear panel of the SAN Volume Controller 2145-DH8

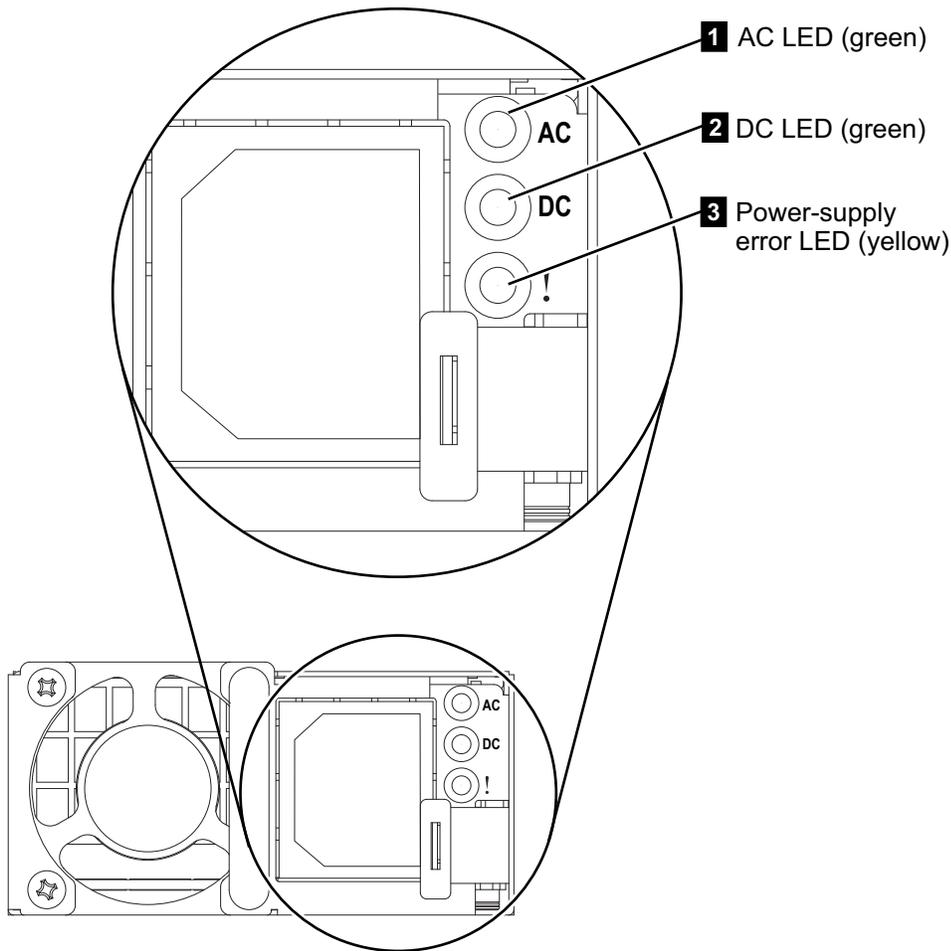
Are the ac LED indicators on the rear of the power supply assemblies illuminated? Figure 74 on page 315 shows the location of the ac LED **1**, the dc LED **2**, and the power-supply error LED **3** on the rear of the power supply assembly that is on the rear panel of the SAN Volume Controller 2145-DH8.

Figure 74. AC, dc, and power-supply error LED indicators on the rear panel of the SAN Volume Controller 2145-DH8

Is the power-supply error LED on the rear of the SAN Volume Controller 2145-DH8 power supply illuminated? Figure 74 shows the location of the power-supply error LED **3**.

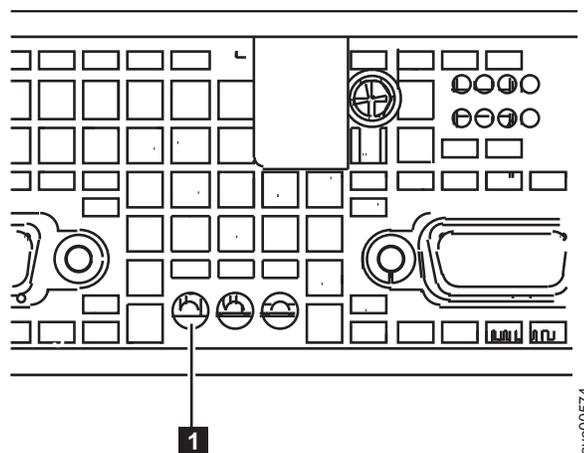
Is the rear panel power LED on or flashing? Figure 76 shows the location of the power LED **1** on the 2145-CF8 or the 2145-CG8.

Figure 76. Power LED indicator on the rear panel of the SAN Volume Controller 2145-CG8 or 2145-CF8

Is the power supply error LED on the rear of the SAN Volume Controller 2145-CG8 or 2145-CF8 power supply assemblies illuminated? Figure 76 on page 319 shows the location of the power LED **1** on the 2145-CF8 or the 2145-CG8.

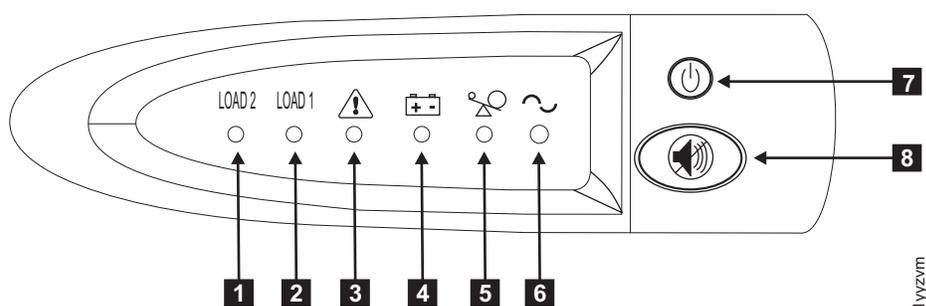
Figure 78 shows an illustration of the front of the panel for the 2145 UPS-1U.

Figure 78. 2145 UPS-1U front-panel assembly

- 1** Load segment 2 indicator
- 2** Load segment 1 indicator
- 3** Alarm
- 4** On-battery indicator
- 5** Overload indicator
- 6** Power-on indicator
- 7** On or off button
- 8** Test and alarm reset button

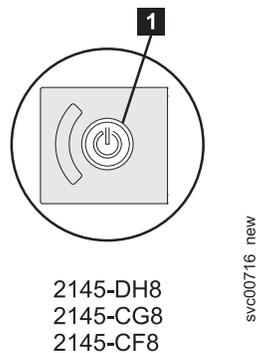
If you must use this method, notice in Figure 79 and Figure 80 that each model type has a power control button **1** on the front.

Figure 79. Power control button on the SAN Volume Controller 2145-CF8, 2145-CG8, and 2145-DH8 models

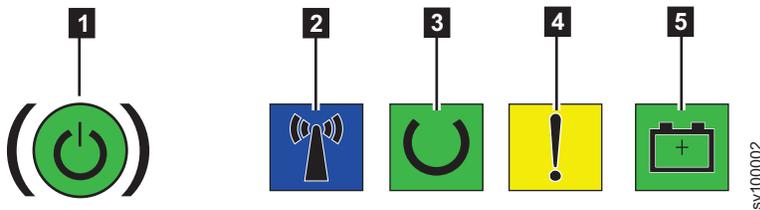
Figure 80. Power control button and LED lights on the SAN Volume Controller 2145-SV1 model

- **1** Power-control button and power-on LED
- **2** Identify LED
- **3** Node status LED
- **4** Node fault LED
- **5** Battery status LED

Note: The 2145-DH8 and 2145-SV1 do not have a front panel display, but status LED **2**, **3**, **4**, and **5** in Figure 80 on page 335 all turn off, and the power-on LED **1** goes from on to flashing.

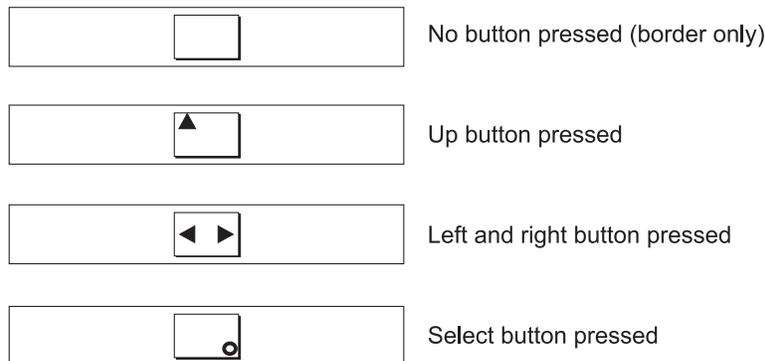
Figure 82 provides four examples of what the front-panel display shows before you press any button and then when you press the up button, the left and right buttons, and the select button. To perform the front panel switch test, press any button in any sequence or any combination. The display indicates which buttons you pressed.

Figure 82. Front-panel display when push buttons are pressed

Check each switch in turn. Did the service panel switches and display operate as described in Figure 82?

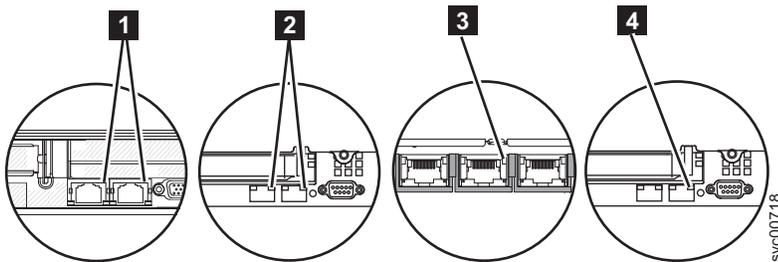
Figure 83. Port 2 Ethernet link LED on the SAN Volume Controller rear panel

- 1** SAN Volume Controller 2145-CG8 port 2 (upper right) Ethernet link LED
- 2** SAN Volume Controller 2145-CF8 port 2 (upper right) Ethernet link LED
- 3** SAN Volume Controller 2145-8G4 port 2 (center) Ethernet link LED
- 4** SAN Volume Controller 2145-8A4 port 2 (upper right) Ethernet link LED

7. (from step 6) **Perform the following actions:**
- a. Plug the Ethernet cable from that node into the Ethernet port 2 from a different node, as shown in Figure 83 and Figure 84 on page 341.

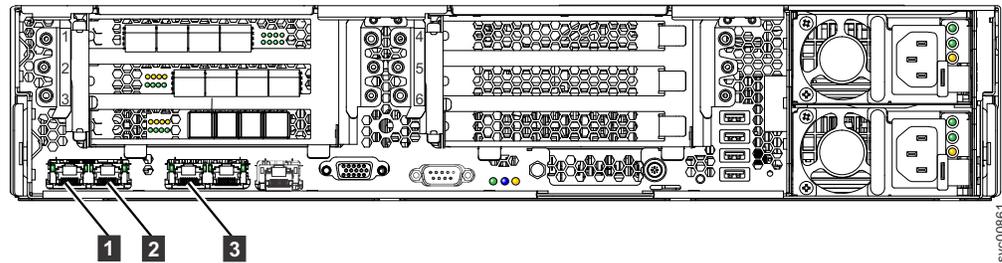
Figure 84. Ethernet ports on the rear of the SAN Volume Controller 2145-DH8

- 1** 1 Gbps Ethernet port 1
- 2** 1 Gbps Ethernet port 2
- 3** 1 Gbps Ethernet port 3

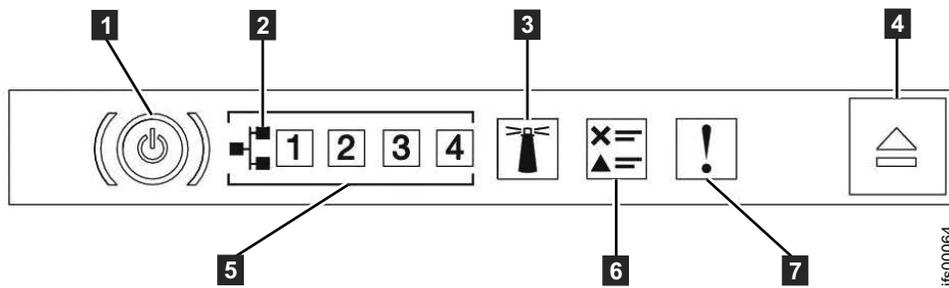
Figure 85. SAN Volume Controller 2145-DH8 operator-information panel

- 1** Power control button and LED.
- 2** Ethernet LED.
- 3** Locator button and LED.
- 4** Release latch.
- 5** Ethernet activity LEDs.
- 6** Check log LED.
- 7** System error LED.

1. Is the System error LED **7**, shown in Figure 85 on page 353, on the SAN Volume Controller 2145-DH8 operator-information panel on or flashing?

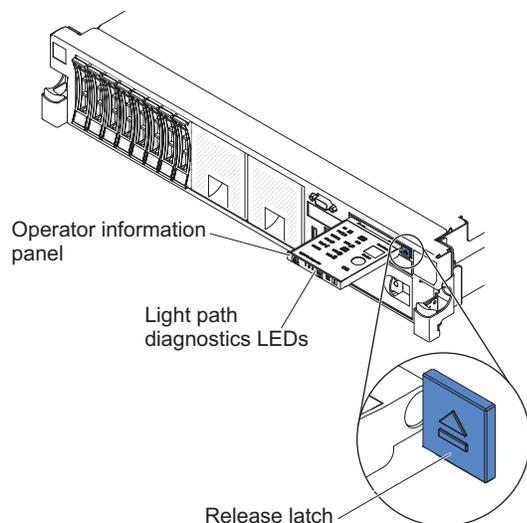
Figure 86. Press the release latch

Press the release latch, as shown in Figure 86, and open the light path diagnostics panel, which is shown in Figure 87 on page 354.

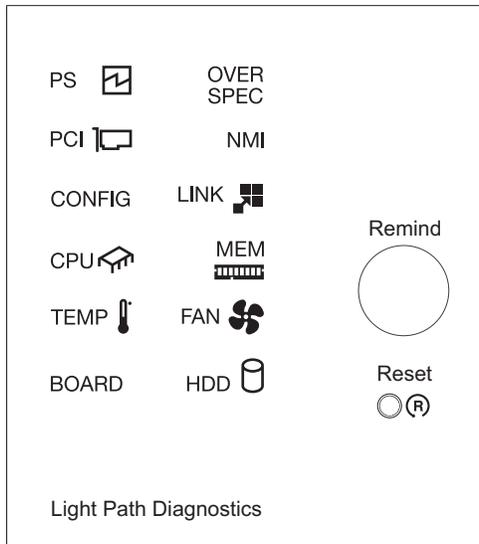
Figure 87. SAN Volume Controller 2145-DH8 light path diagnostics panel

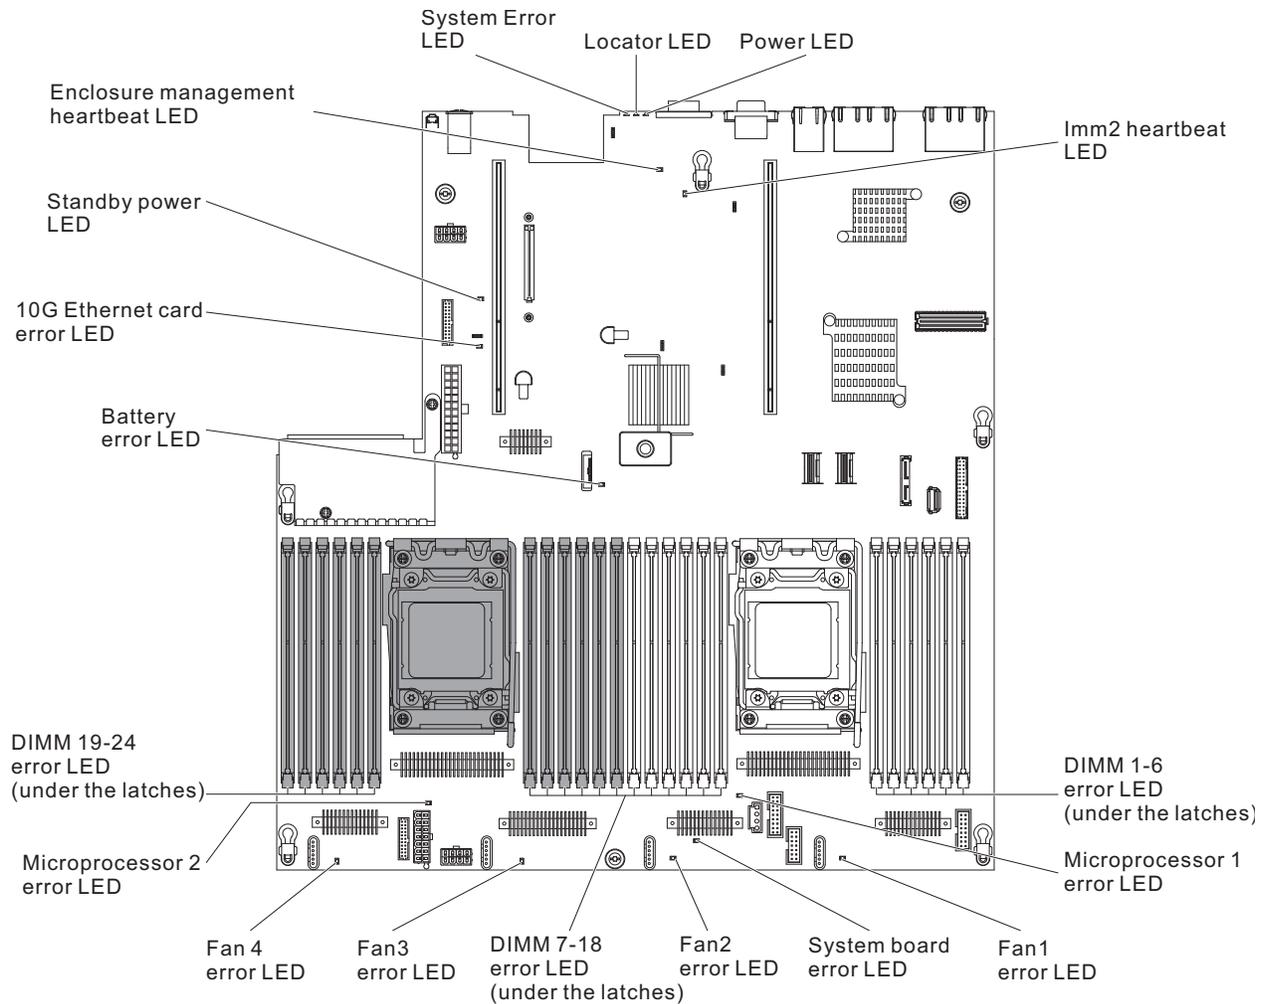
Figure 88. SAN Volume Controller 2145-DH8 system board LEDs.

YES See Table 80 on page 355 and complete the action that is specified for the specific light-path-diagnostics LEDs. Then, go to step 3 on page 359. Some actions require that you observe the state of LEDs on the system board. Figure 88 on page 355 shows the location of the system board LEDs. The fan LEDs are located next to each FAN. To view the LEDs, complete the following actions:

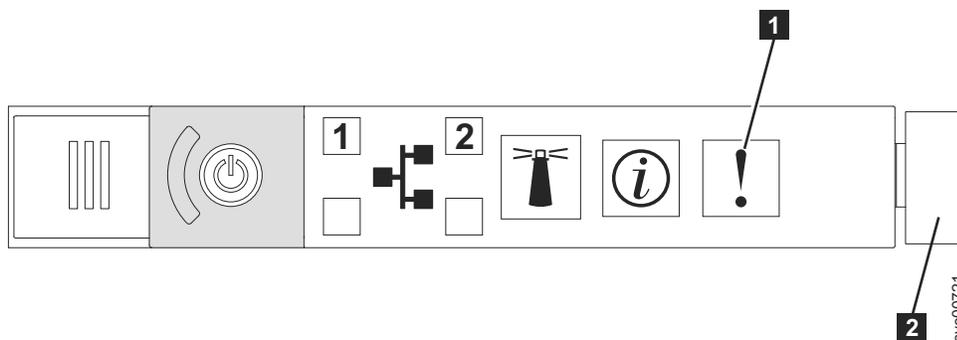
Figure 89. SAN Volume Controller 2145-CG8 or 2145-CF8 operator-information panel

- 1** System error LED.
- 2** Release latch.

1. Is the Error LED, shown in Figure 89, on the SAN Volume Controller 2145-CG8 operator-information panel on or flashing?

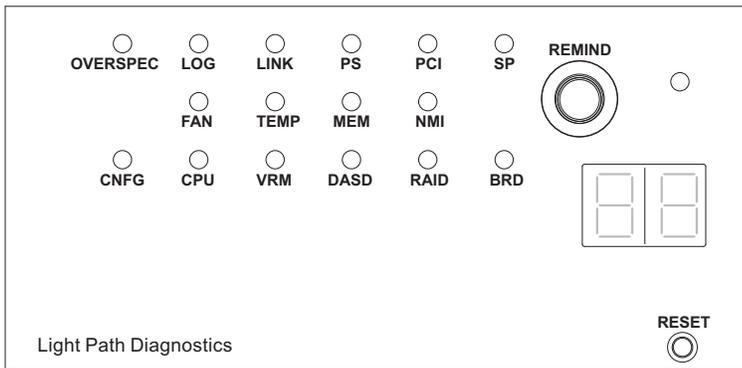
Figure 90. SAN Volume Controller 2145-CG8 or 2145-CF8 light path diagnostics panel

Press the release latch and open the light path diagnostics panel, which is shown in Figure 90 on page 360.

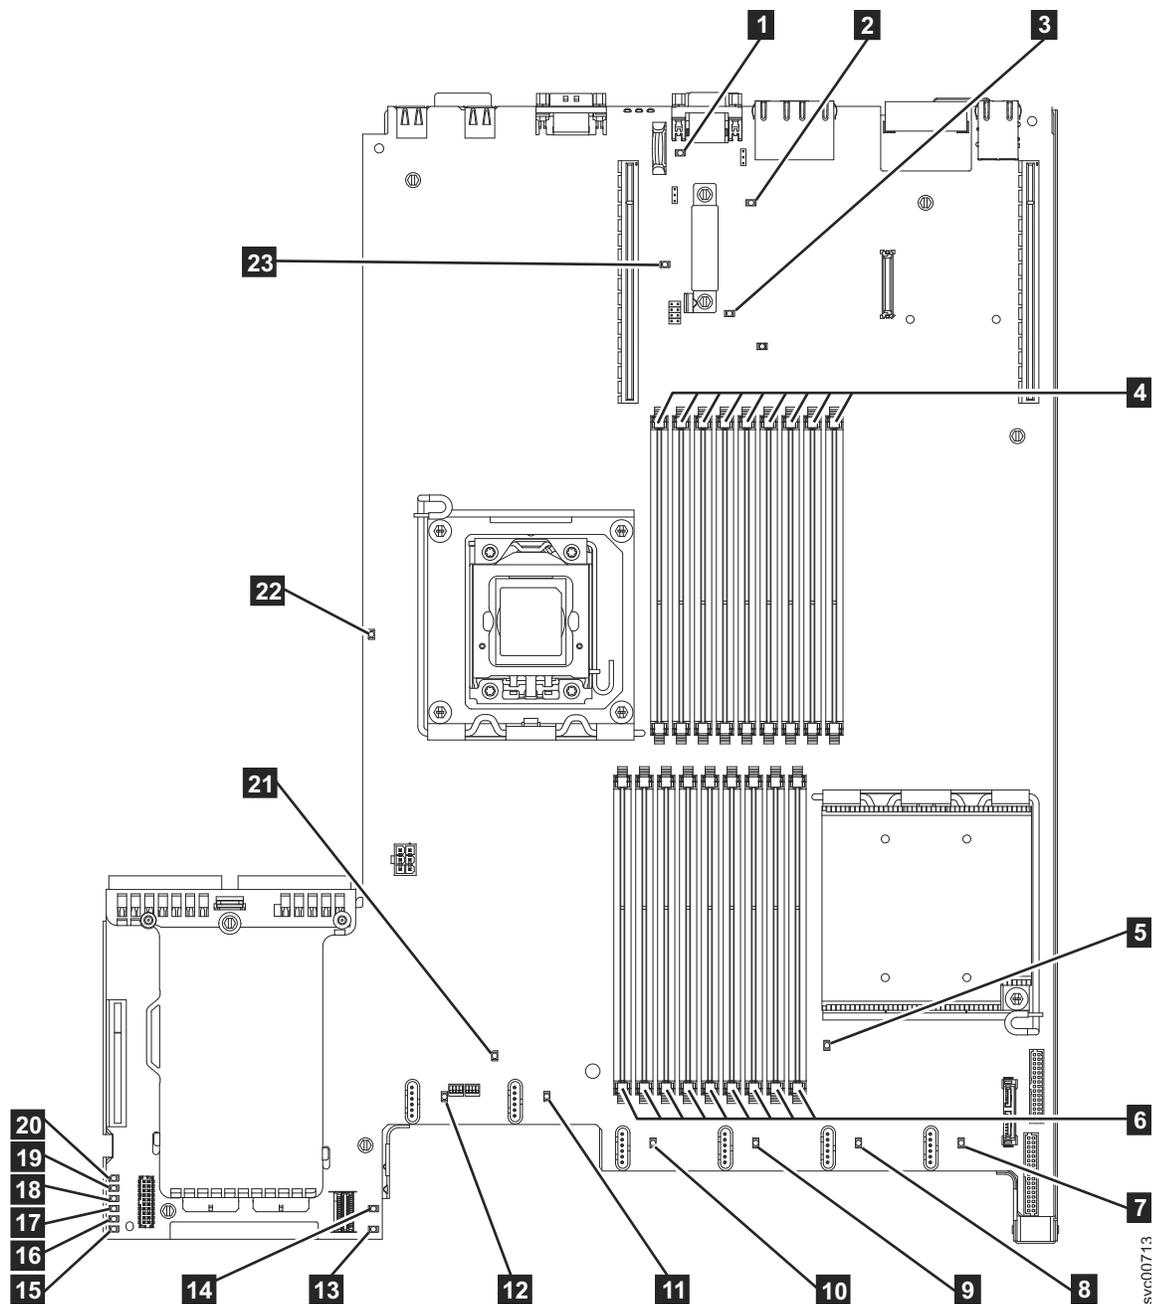
Figure 91. SAN Volume Controller 2145-CG8 system board LEDs diagnostics panel

- 1** Battery LED.
- 2** IMM heartbeat LED.
- 3** Enclosure management heartbeat LED.
- 4** DIMM 10-18 error LEDs.
- 5** Microprocessor 1 error LED.
- 6** DIMM 1-9 error LEDs.
- 7** Fan one error LED.
- 8** Fan two error LED.
- 9** Fan three error LED.
- 10** Fan four error LED.

YES See Table 81 on page 362 and complete the action that is specified for the specific light-path-diagnostics LEDs. Then, go to step 3 on page 364. Some actions require that you observe the state of LEDs on the system board. Figure 91 on page 361 shows the location of the system board LEDs. The fan LEDs are located next to each FAN. To view the LEDs, complete the following actions:

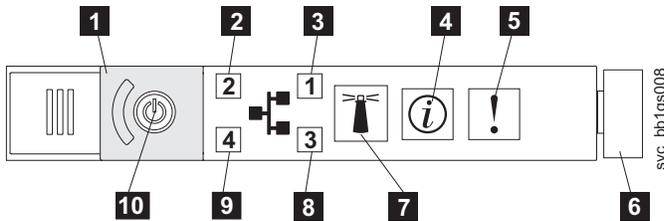
Figure 92. SAN Volume Controller 2145-CG8 or 2145-CF8 operator-information panel

5 System error LED.

1. Is the Error LED, shown in Figure 92, on the SAN Volume Controller 2145-CF8 operator-information panel on or flashing?

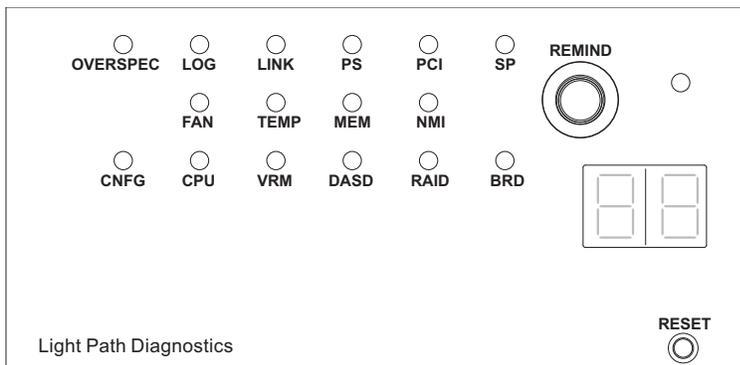
Figure 93. SAN Volume Controller 2145-CG8 or 2145-CF8 light path diagnostics panel

Press the release latch and open the light path diagnostics panel, which is shown in Figure 93.

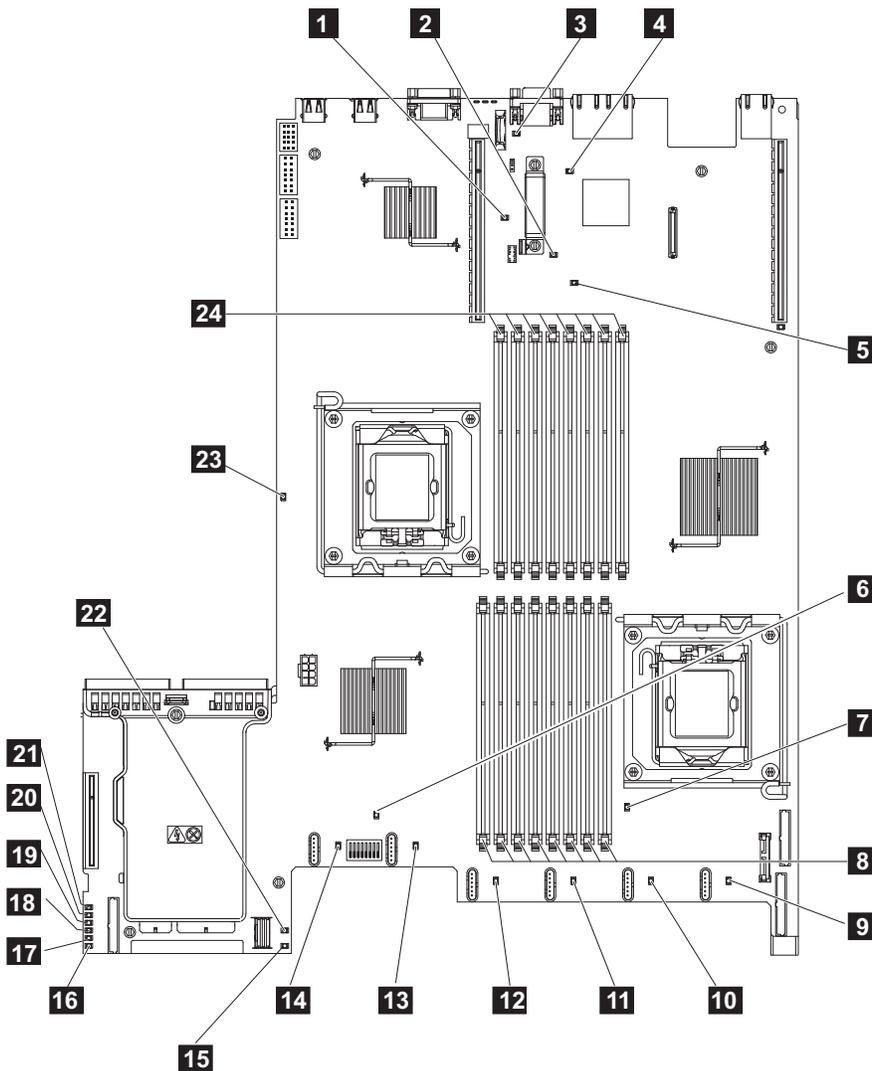
Figure 94. SAN Volume Controller 2145-CF8 system board LEDs diagnostics panel

- 1** Slot 2 missing PCI riser card LED.
- 2** Enclosure manager heartbeat LED.
- 3** Battery LED.
- 4** IMM heartbeat LED.
- 5** Slot 1 missing PCI riser card LED.
- 6** System error LED.
- 7** Microprocessor 1 error LED.
- 8** DIMM 1-8 error LEDs.
- 9** Fan one error LED.
- 10** Fan two error LED.
- 11** Fan three error LED.
- 12** Fan four error LED.
- 13** Fan five error LED.
- 14** Fan six error LED.
- 15** 240 VA error LED.
- 16** Power channel A error LED.
- 17** Power channel B error LED.
- 18** Power channel C error LED.
- 19** Power channel D error LED.
- 20** Power channel E error LED.
- 21** AUX power channel error LED.
- 22** SAS/SATA RAID error LED.
- 23** Microprocessor 2 error LED.
- 24** DIMM 9-16 error LEDs.

YES See Table 82 on page 368 and complete the action that is specified for the specific light-path-diagnostics LEDs. Then, go to step 3 on page 370. Some actions require that you observe the state of LEDs on the system board. Figure 94 shows the location of the system board LEDs. The fan LEDs are located next to each FAN. To view the LEDs, complete the following actions:

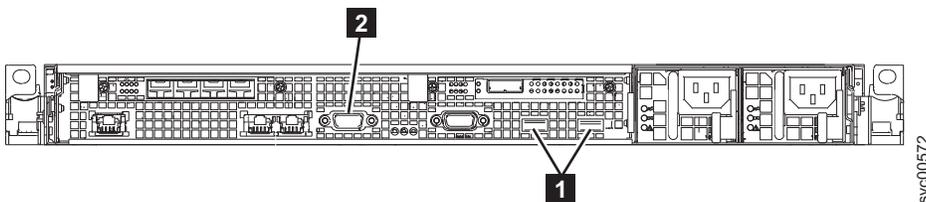
Figure 97. Keyboard and monitor ports on the SAN Volume Controller 2145-CF8

- a. Turn off the node while ensuring that its data is mirrored and synchronized. See “MAP 5350: Powering off a node” on page 331.
- b. Connect the keyboard and the display. Figure 97 shows the location of the keyboard and monitor ports on the 2145-CF8. Figure 98 shows the location of the keyboard and monitor ports on the 2145-CG8. Connect to the VGA port and a USB port on the front or the back of a 2145-DH8.

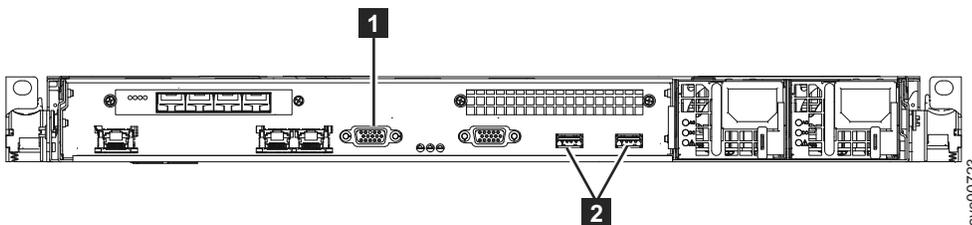
Figure 98. Keyboard and monitor ports on the SAN Volume Controller 2145-CG8

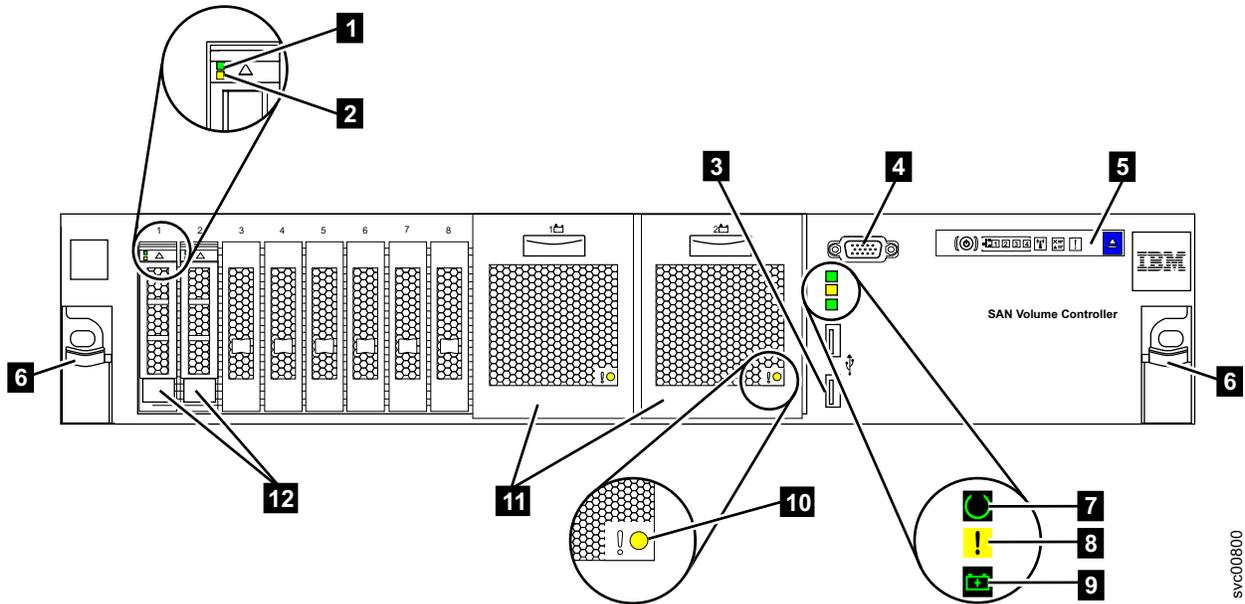
- 3** USB port 1 and 2
- 4** Video port

Figure 99. Keyboard and monitor ports on the SAN Volume Controller 2145-DH8, front

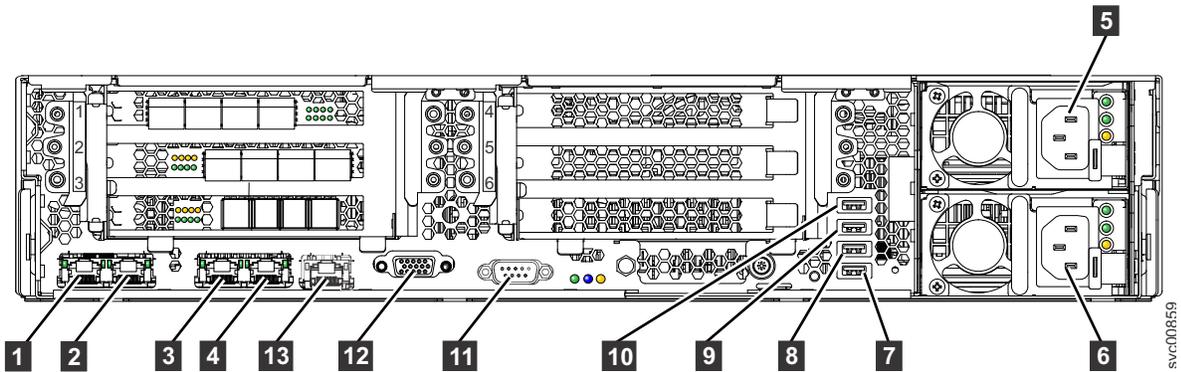
- 7** USB port 6
- 8** USB port 5
- 9** USB port 4
- 10** USB port 3
- 11** Serial port
- 12** Video port

Figure 100. Keyboard and monitor ports on the SAN Volume Controller 2145-DH8, rear
