Flex System Manager Types 7955, 8731, and 8734
Installation and Service Guide

Third Edition (June 2014)

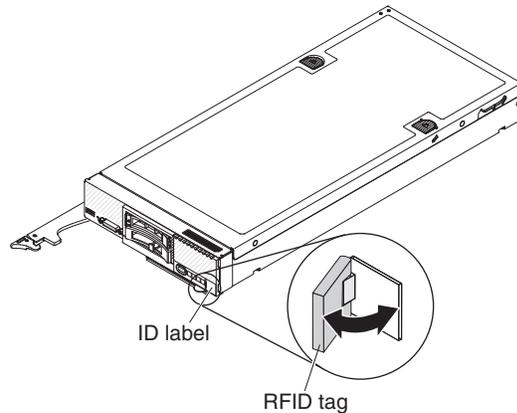
The model number and serial number are on the ID label on the bezel on the front of the management node, and on a label on the bottom of the management node that is visible when the management node is not in the Flex System Enterprise

Chassis. If the management node comes with an RFID tag, the RFID tag covers the ID label on the bezel on the front of the management node but you can open the RFID tag to see the ID label behind it.

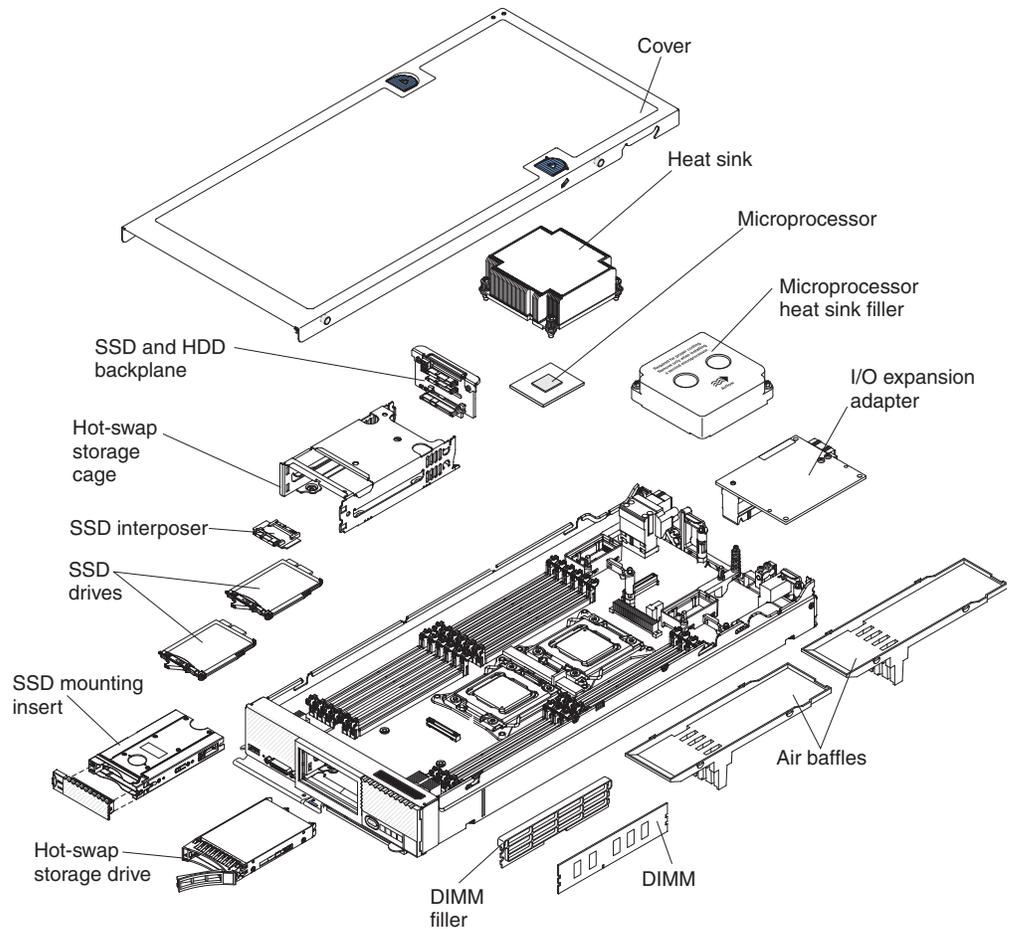
The following illustration shows the major components of the management node.

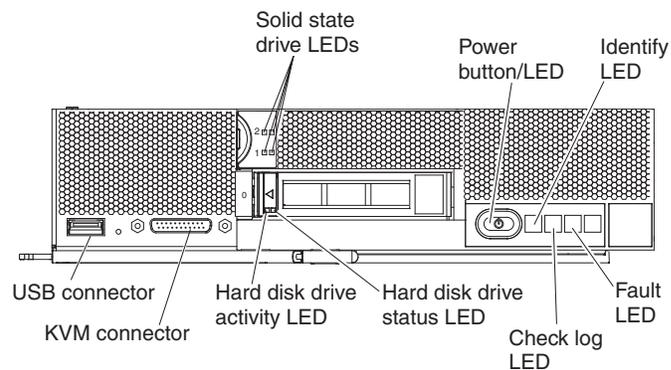
The following illustration identifies the buttons, connectors, and LEDs on the Flex System Manager Types 7955, 8731, and 8734 control panel.

Solid state drive activity LED (green)

When this green LED is lit, it indicates that there is activity on the solid state drive.

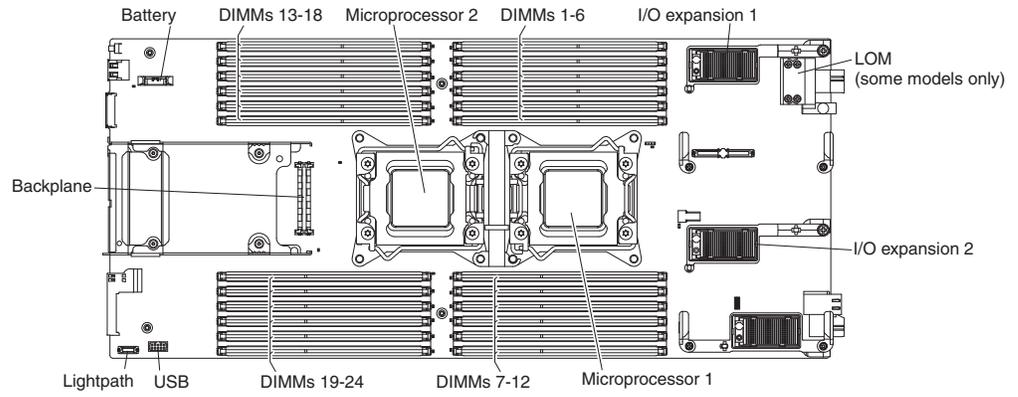
The following illustration shows the system-board components, including connectors for user-installable optional devices, in the Flex System Manager Types 7955, 8731, and 8734 management node.

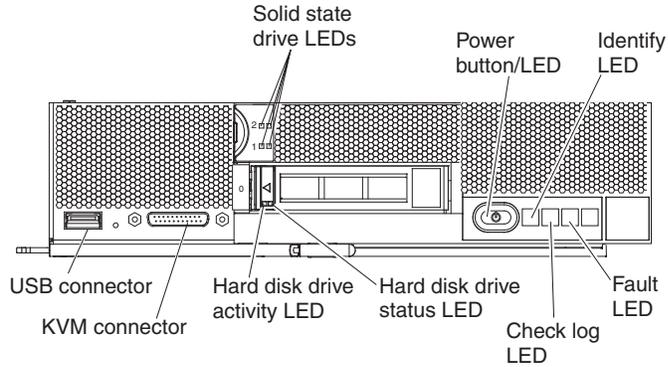
1. Look at the control panel on the front of the node (see “Management node controls, connectors, and LEDs” on page 7).

- If the check log LED is lit, it indicates that a condition that causes an event to log in the IMM event log has occurred.
 - If the fault LED is lit, it indicates that an error has occurred; view the light path diagnostics panel and LEDs to isolate the failing component.

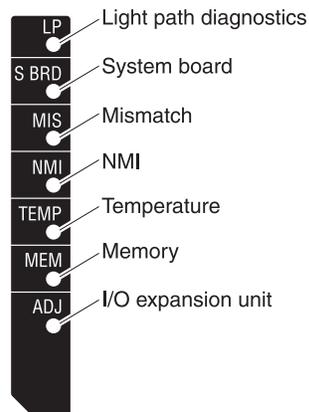
The following illustration shows the LEDs on the light path diagnostics panel.

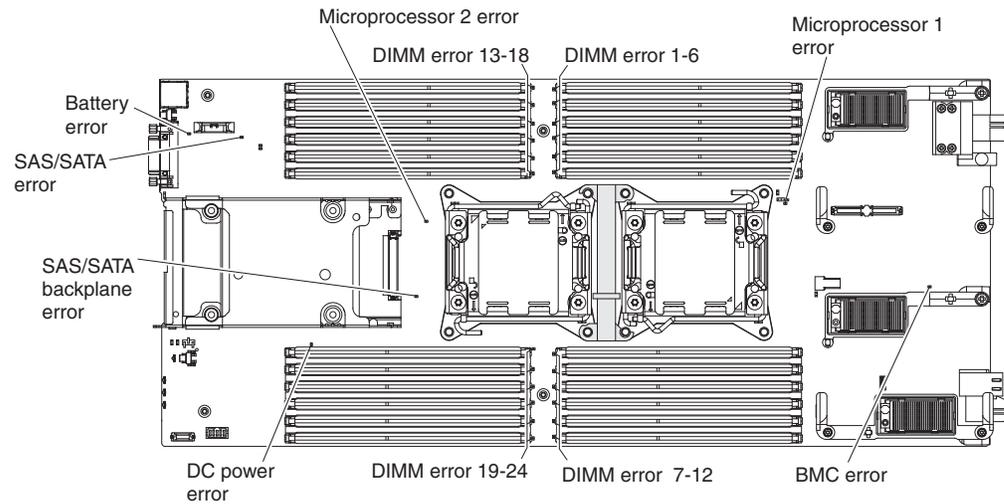
The following illustration shows the location of the light path diagnostics LEDs on the system board.

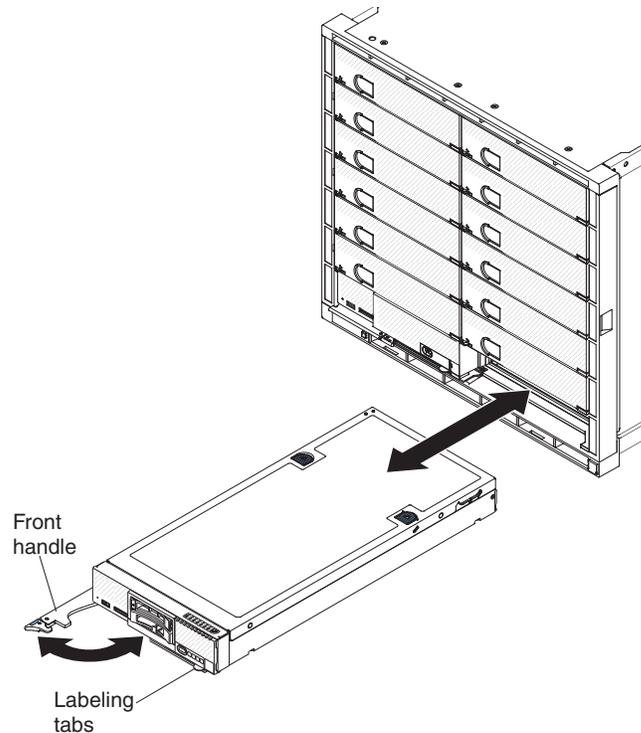
To unmanage the Chassis Management Module (CMM) and remove the Flex System Manager Types 7955, 8731, and 8734, complete the following steps:

1. Read “Safety” on page v and “Installation guidelines” on page 417.
2. On the management software web interface Home page, click the **Plug-ins** tab.
3. Under **IBM Flex System Manager**, click the **FSM Management Domain** link.
4. On the Management Domain page, select all of the chassis under management software; then, click **Unmanage**.
5. Use either the management software web interface to turn off the node or press the power button to turn off the Flex System Manager Types 7955, 8731, and 8734 (see “Turning off the management node” on page 10 for more information).

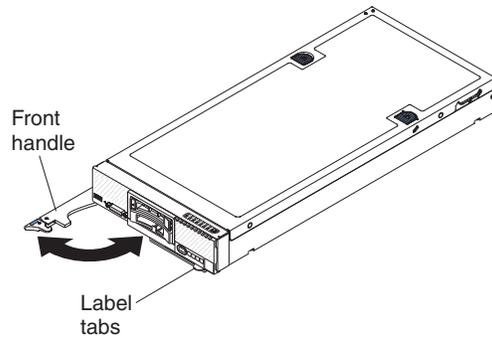
1. Open the front handle as shown in the illustration. The node moves out of the node bay approximately 0.6 cm (0.25 inch).

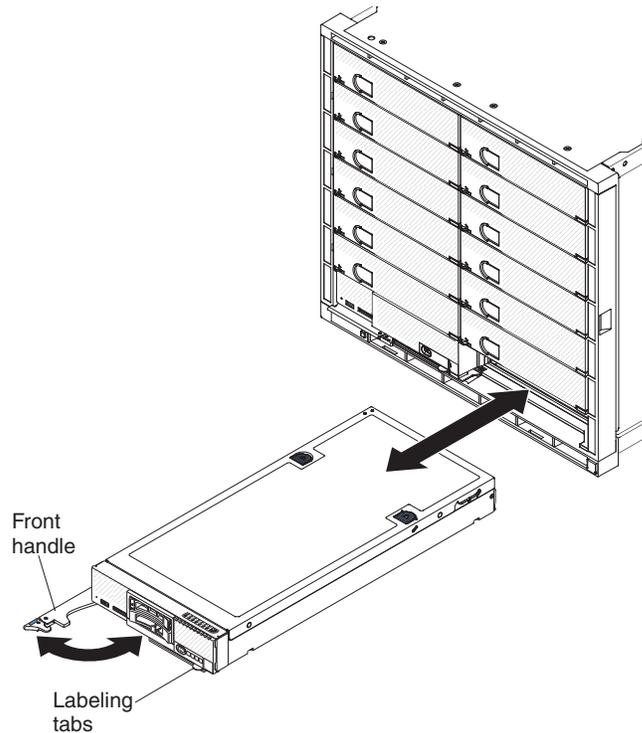
To install the management node in a chassis, complete the following steps.

1. Select the node bay.

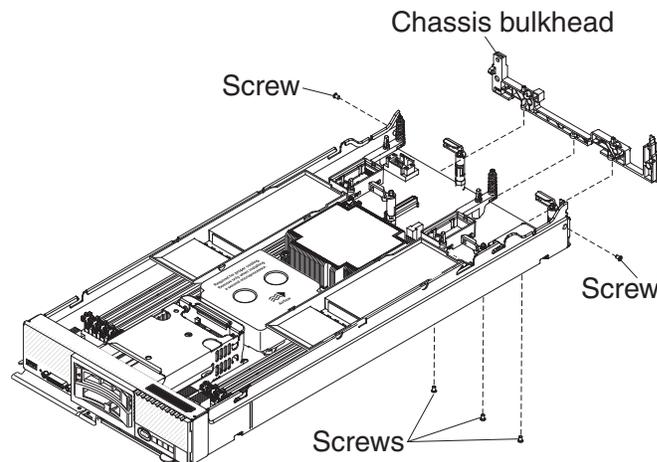
To remove the chassis bulkhead, complete the following steps.

1. Remove the cover (see “Removing the management node cover” on page 431).

2. Remove the I/O expansion adapters (see “Removing an I/O expansion adapter” on page 455).
3. Remove the fabric connector (see “Removing a fabric connector” on page 449).
4. Carefully place the chassis on its side with the front handle side up.

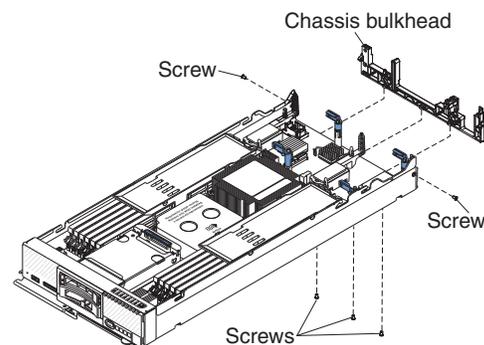
To install the chassis bulkhead, complete the following steps.

1. Remove the cover (see “Removing the management node cover” on page 431).
2. Position the bulkhead in the chassis.
3. Using a T8 Torx screwdriver, install the screws that secure the bulkhead to the sides of the chassis.
4. Carefully place the chassis on its side with the front handle up.

5. Using a T8 Torx screwdriver, install the screws that secure the bulkhead to the bottom of the chassis.
6. Carefully return the chassis to the bottom-side-down orientation.
7. Install the I/O expansion adapters (see “Installing an I/O expansion adapter” on page 456).
8. Install the air baffles, if you removed them.

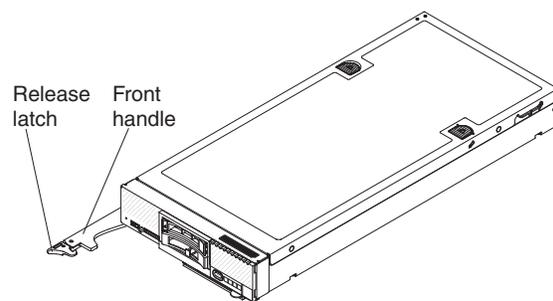
To remove the front handle, complete the following steps.

1. Locate the screw that attaches the handle to the management node.
2. Using a T15 Torx screwdriver, remove the screw from the front handle and save the screw in a safe place. Use the same screw when installing a front handle.

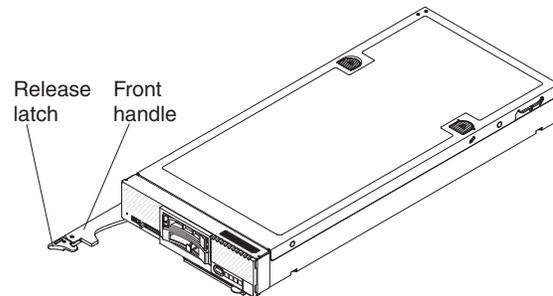
To install the front handle, complete the following steps.

1. Orient the front handle so that the blue release latch is toward the middle of the management node.
2. Align the hole in the handle with the hole on the management node where the handle is installed.
3. Using a T15 Torx screwdriver, install the screw that secures the handle. Install the screw that you removed when you removed the handle.

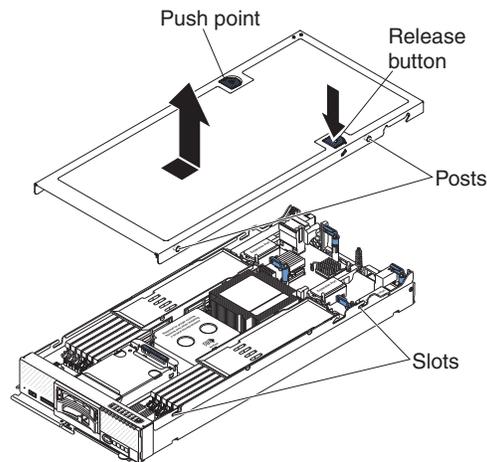
1. Press on the release button and the push point at the same time and slide the cover toward the rear of the management node.
2. Lift the cover away from the management node.

3. Lay the cover flat or store it for future use.

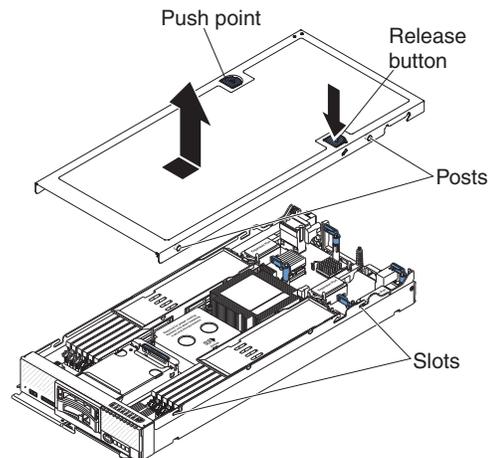
1. Carefully lay the management node on a flat, static-protective surface, orienting the management node with the bezel pointing toward you.
2. Orient the cover so that the pins on the inside of the cover slide into the slots on the management node.

3. Hold the front of the management node and slide the cover forward to the closed position, until it clicks into place.
4. To install a system service label, align the label on the cover, remove the backing, and press the label on the cover.

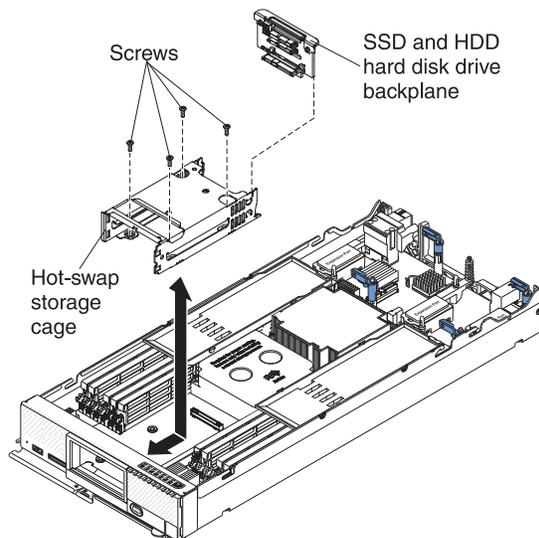
To remove the hot-swap storage cage, complete the following steps.

1. Remove the cover (see “Removing the management node cover” on page 431).
2. Remove the hot-swap storage drives and storage drive fillers.
3. Remove the hot-swap storage backplane (see “Removing the hot-swap storage backplane” on page 451).
4. Using a T8 Torx screwdriver, remove the four screws from the cage and slide it out from under the bezel; then, remove the cage from the node.

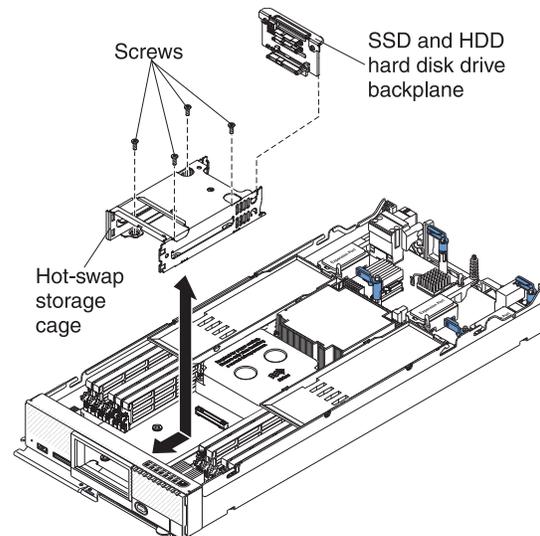
To install the hot-swap storage cage, complete the following steps.

1. Remove the cover (see “Removing the management node cover” on page 431).
2. Position the cage in the compute node.
3. Align the cage with the screw holes on the system board.
4. Insert the four screws and secure the cage in the node.
5. Remove the small MAC address label envelope from the cage.
Attention: Make sure that the MAC address label envelope is removed from the cage before you insert the drive. Otherwise, you might damage the drive connector.
6. Install the hot-swap storage backplane (see “Installing the hot-swap storage backplane” on page 451).
7. Insert the hot-swap storage drives and storage drive fillers.

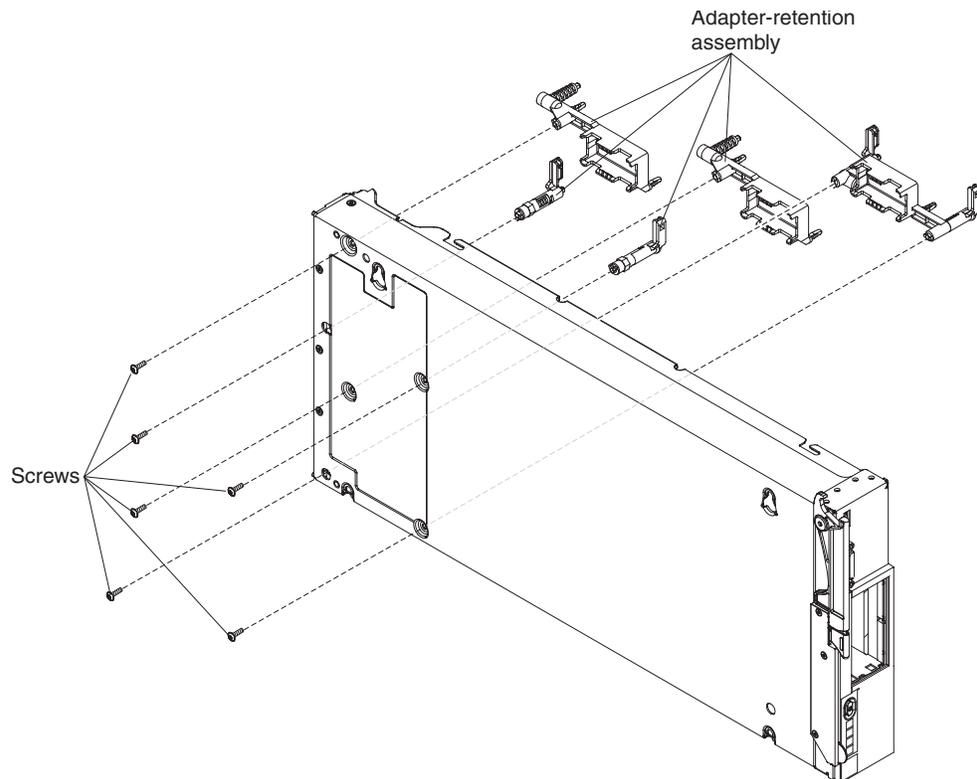
To remove the adapter-retention assembly, complete the following steps.

2. Remove the air baffles.
3. If necessary, remove the I/O expansion adapters (see “Removing an I/O expansion adapter” on page 455).
4. Carefully place the chassis on its side with the front handle side up.
5. Using a T10 Torx screwdriver, remove the six screws that secure the adapter-retention assembly.
6. Lift the adapter-retention assembly from the system board.
7. Carefully return the chassis to the bottom-side-down orientation.

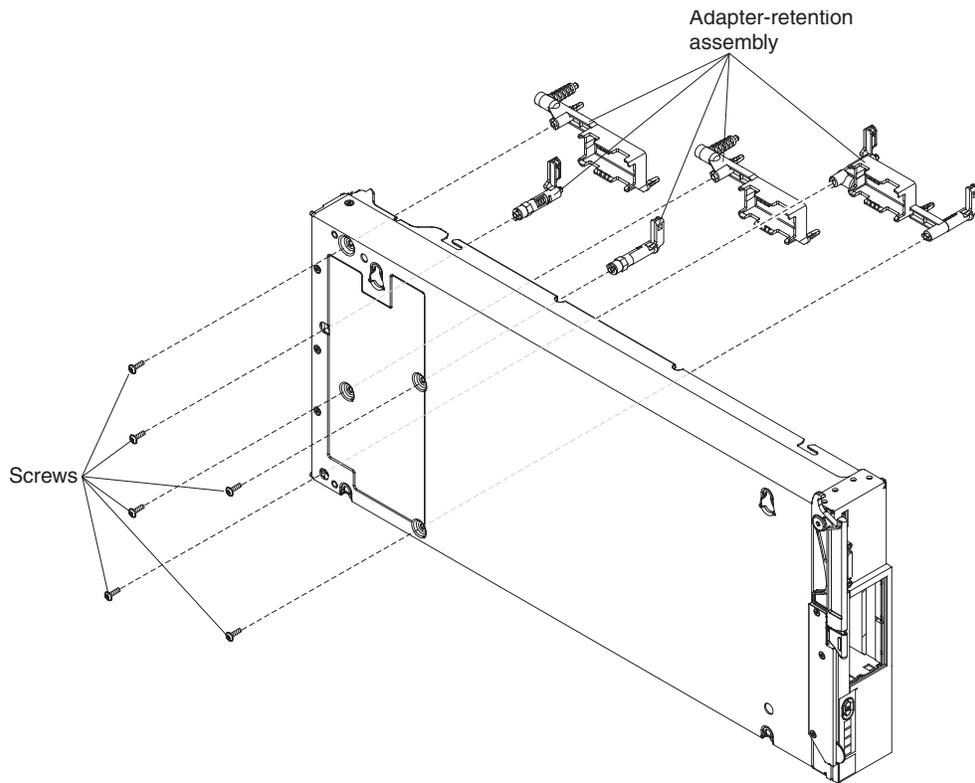
To install the adapter-retention assembly, complete the following steps.

1. Remove the cover (see “Removing the management node cover” on page 431).
2. Remove the air baffles.
3. Carefully place the chassis on its side with the front handle side up.
4. Align the adapter-retention assembly on the system board.
5. Using a T10 Torx screwdriver, install the screws that secure the adapter-retention assembly.
6. Carefully return the chassis to the bottom-side-down orientation.
7. Install the I/O expansion adapters, if you removed them (see “Installing an I/O expansion adapter” on page 456).
8. Install the air baffles.

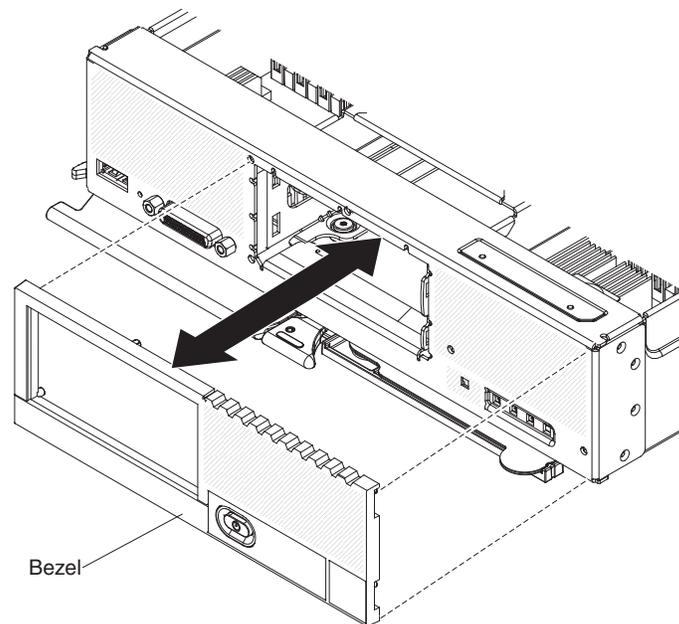
To remove the bezel, complete the following steps.

1. Use a flat-blade screwdriver to carefully pull the bezel from the management node.
2. Lift the bezel from the node.

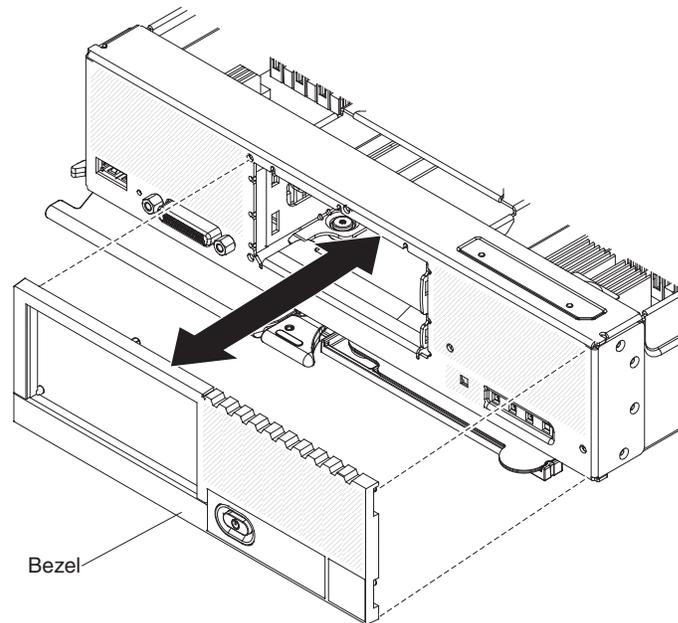
To install the bezel, complete the following steps.

1. Position the bezel on the front of the compute node.
2. Press the bezel securely against the chassis.

Note: Make sure that the bezel is pressed flat against the chassis around the power button, to maintain access to the power button.

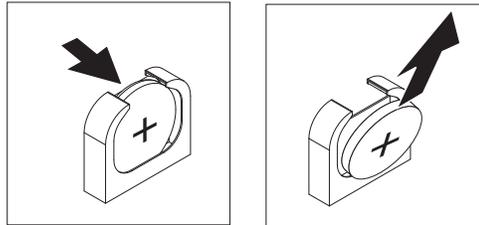
1. Remove the cover (see “Removing the management node cover” on page 431).
2. Locate the CMOS battery on the system board (see “System-board connectors” on page 10).
3. If a cover is over the CMOS battery, remove the cover.
4. Pivot the CMOS battery toward the middle of the compute node.

5. Lift the CMOS battery from the socket.

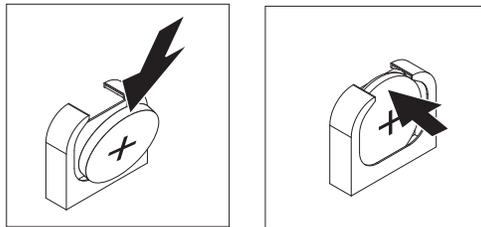
1. Remove the cover (see “Removing the management node cover” on page 431).
2. Follow any special handling and installation instructions that come with the CMOS battery.
3. Locate the CMOS battery socket on the system board (see “System-board connectors” on page 10).
4. Orient the CMOS battery so that the positive (+) side faces in toward the center of the compute node.

5. Pivot the CMOS battery so that you can insert it into the bottom of the socket.
6. As you slide the CMOS battery into place, press the top of the CMOS battery into the socket.
7. If you removed a cover from the battery, replace the cover.

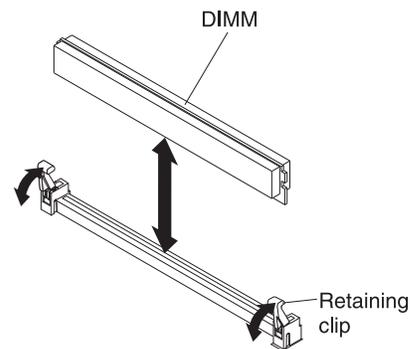
To remove a DIMM, complete the following steps.

1. Remove the cover (see “Removing the management node cover” on page 431).
2. Remove the air baffle installed over the DIMM connector.

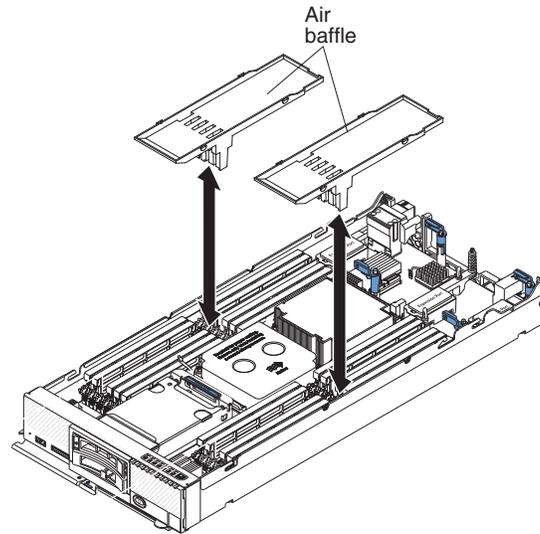
3. Locate the DIMM connectors (see “System-board connectors” on page 10). Determine which DIMM you want to remove from the management node.
Attention: To avoid breaking the retaining clips or damaging the DIMM connectors, handle the clips gently.
4. Make sure that both retaining clips on the DIMM connector from which you are removing the DIMM are in the open position.
5. Pull the DIMM out of the connector.
6. If you are not immediately replacing the DIMM, install the air baffles.
Attention: To maintain proper system cooling, do not operate the compute node without air baffles installed over the DIMM connectors.

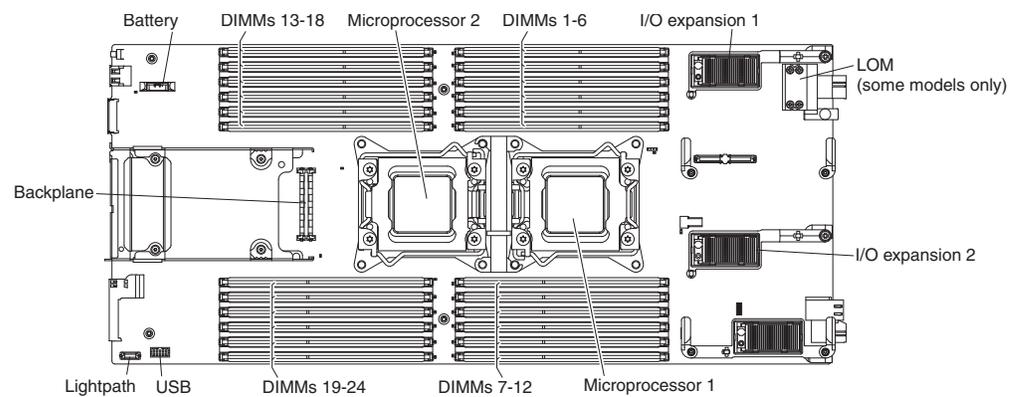
The management node has a total of 24 dual inline memory module (DIMM) connectors. The management node supports low-profile (LP) DDR3 DIMMs with error code correction (ECC) in 2 GB, 4 GB, 8 GB, and 16 GB capacities.

The following illustration shows the system-board components, including the DIMM connectors.

The memory is accessed internally through eight channels (four channels for each microprocessor). Each channel contains three DIMM connectors. Each channel can have a maximum of eight ranks. The following table lists each channel and shows which DIMM connectors are in the channel.

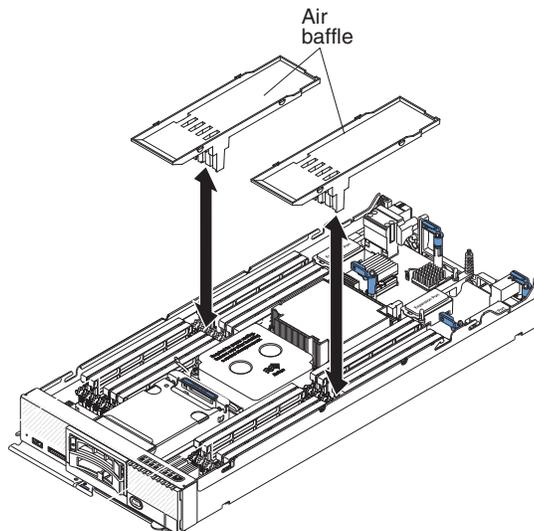
1. Remove the cover (see “Removing the management node cover” on page 431).
2. Read the documentation that comes with the DIMM.
3. Remove the air baffle.

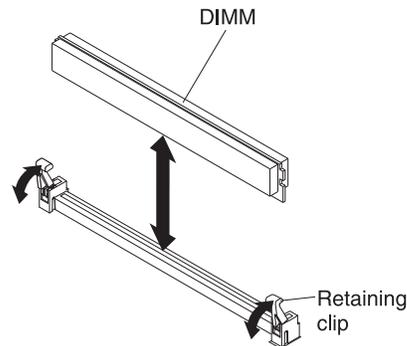
- a. Make sure that both retaining clips on the DIMM connector into which you are installing the DIMM are in the open position.
- b. Turn the DIMM so that the DIMM keys align correctly with the DIMM connector on the system board.

- c. Press the DIMM into the DIMM connector. The retaining clips lock the DIMM into the connector.
- d. Make sure that the small tabs on the retaining clips engage the notches on the DIMM. If there is a gap between the DIMM and the retaining clips, the DIMM has not been correctly installed. Press the DIMM firmly into the connector, and then press the retaining clips toward the DIMM until the tabs are fully seated. When the DIMM is correctly installed, the retaining clips are parallel to the sides of the DIMM.

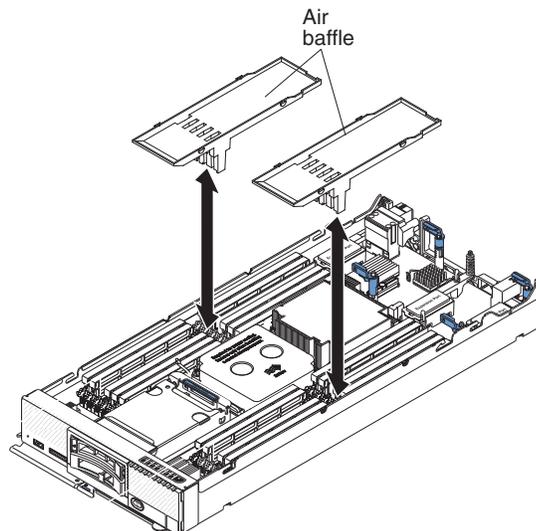
8. Install the air baffles.

Attention: To maintain proper system cooling, do not operate the management node without air baffles installed over the DIMM connectors.

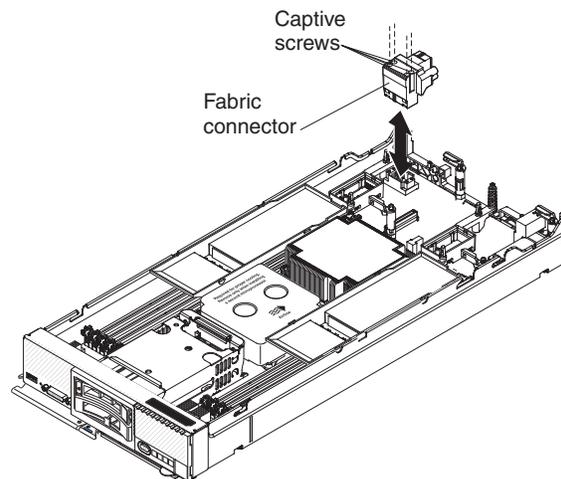
To install a fabric connector, complete the following steps.

1. Remove the cover (see “Removing the management node cover” on page 431).
2. Locate the fabric connector (see “System-board connectors” on page 10).
3. Orient the fabric connector on the system board.
4. Using a Phillips screwdriver, tighten the four captive screws to secure the fabric connector.

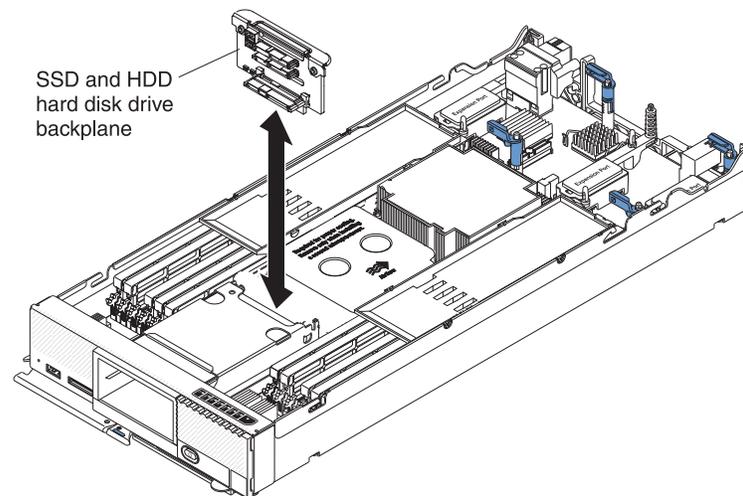
To remove the hot-swap storage backplane, complete the following steps.

1. Remove the cover (see “Removing the management node cover” on page 431).
2. Remove the hot-swap storage drives and storage drive fillers.
3. Lift out the hot-swap storage backplane.

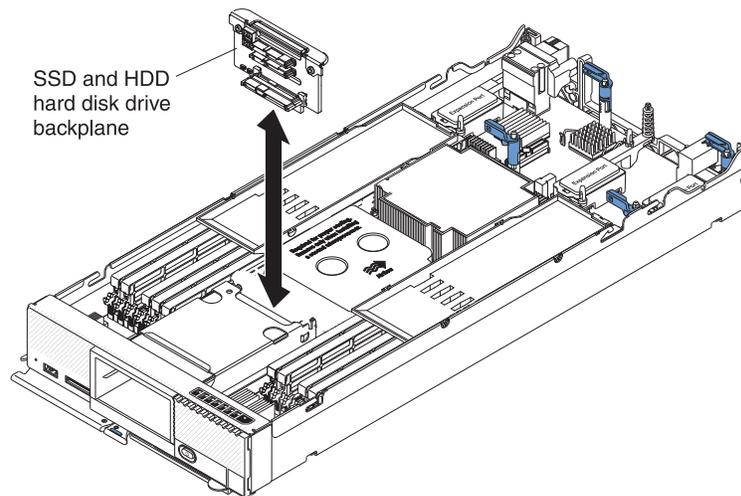
To install the hot-swap storage backplane, complete the following steps.

1. Remove the cover (see “Removing the management node cover” on page 431).
2. Align the backplane with the hot-swap storage cage and the connector on the system board and press the backplane into position until it is fully seated in the connector.
3. Insert the hot-swap storage drives and storage drive fillers.

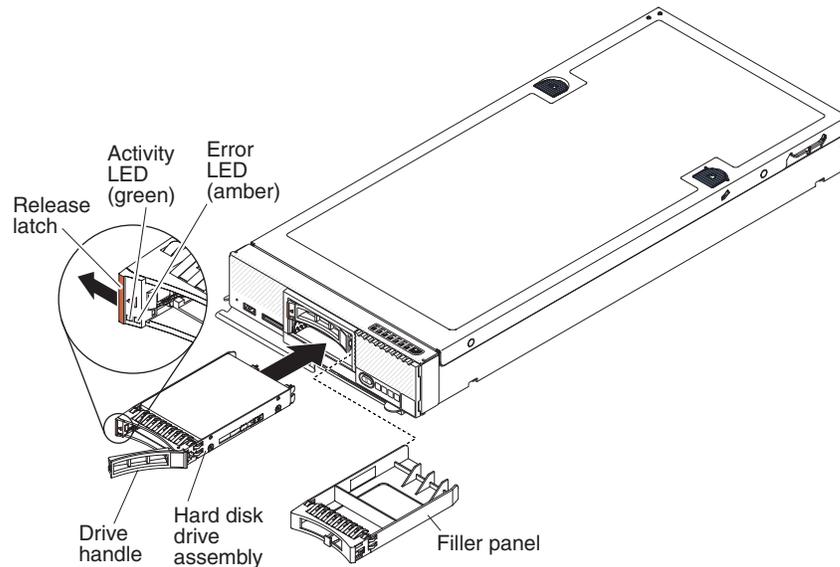
To remove a hot-swap storage drive, complete the following steps.

1. Press the release latch (orange) on the storage drive to release the drive handle.
2. Pull the release handle to remove the drive from the storage bay.

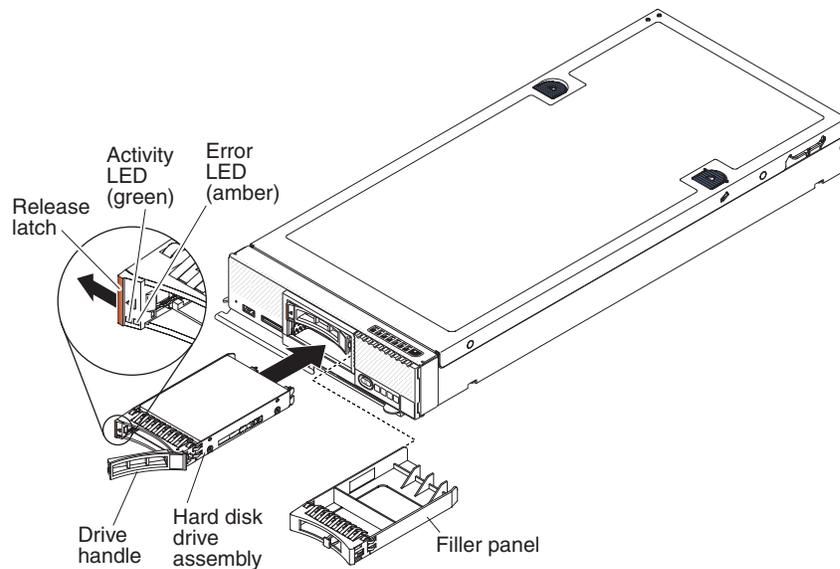
The node has one SAS or SATA storage bay for installing a hot-swap storage drive, such as a hot-swap SAS hard disk drive.

To install a hot-swap storage drive or drive filler, complete the following steps.

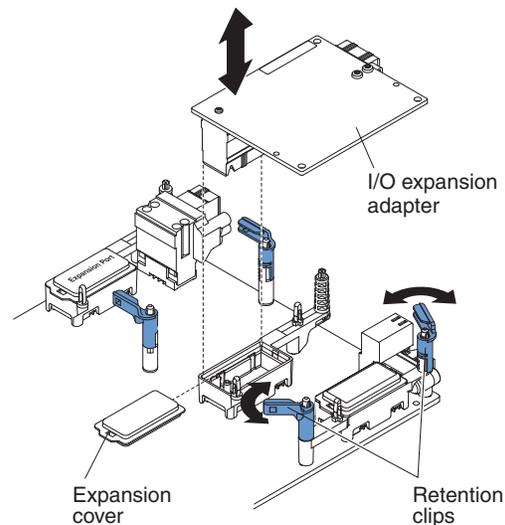
To remove an I/O expansion adapter, complete the following steps.

1. Remove the cover (see “Removing the management node cover” on page 431).
2. Locate the I/O expansion adapter connectors (see “System-board connectors” on page 10).
3. Open the retention clips.
4. Lift the I/O expansion adapter from the connector and remove the I/O expansion adapter from the node. You might find it helpful to rock the adapter back and forth to disengage the adapter.

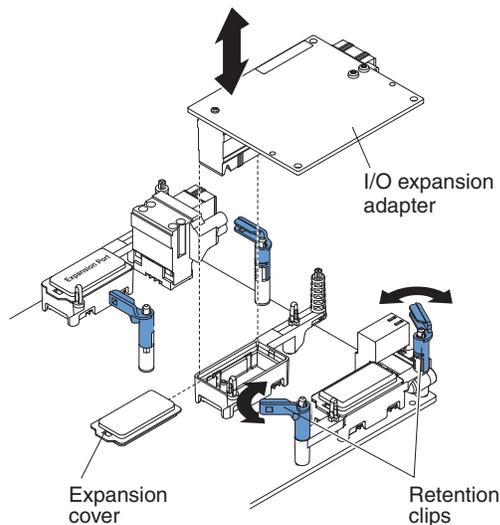
To install an I/O expansion adapter, complete the following steps:

1. Remove the cover (see “Removing the management node cover” on page 431).
2. Locate the I/O expansion connectors (see “System-board connectors” on page 10).
3. Remove the expansion cover from the connector, if one is present.
4. Touch the static-protective package that contains the expansion adapter to any *unpainted* metal surface on the Flex System Enterprise Chassis or any *unpainted* metal surface on any other grounded rack component; then, remove the expansion adapter from the package.
5. Open the retention clips.
6. Orient the connector on the expansion adapter with the I/O expansion connector and alignment pins on the system board; then, press the adapter into the I/O expansion connector.

7. Firmly press on the indicated locations to seat the expansion adapter in the connector and over the alignment pins.
8. Close the retention clips.

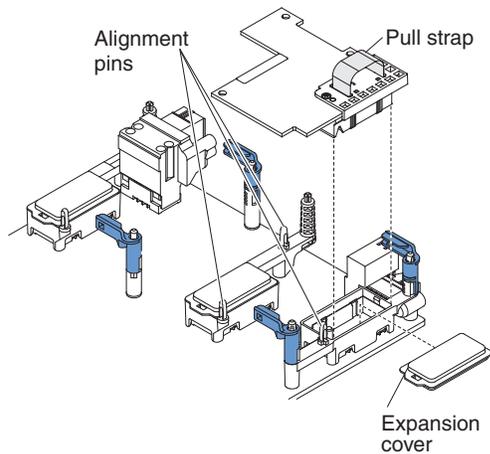
To remove an Flex System Manager Network Adapter, complete the following steps.

1. Locate the Flex System Manager Network Adapter connector (see “System-board connectors” on page 10).
2. If an I/O expansion adapter is installed over the Flex System Manager Network Adapter connector, remove it (see “Removing an I/O expansion adapter” on page 455).
3. Use the pull strap on the top of the Flex System Manager Network Adapter to lift it from the connector, and remove the adapter from the management node. You might find it helpful to rock the adapter back and forth to disengage the adapter.
4. If necessary, install the I/O expansion adapter (see “Installing an I/O expansion adapter” on page 456).

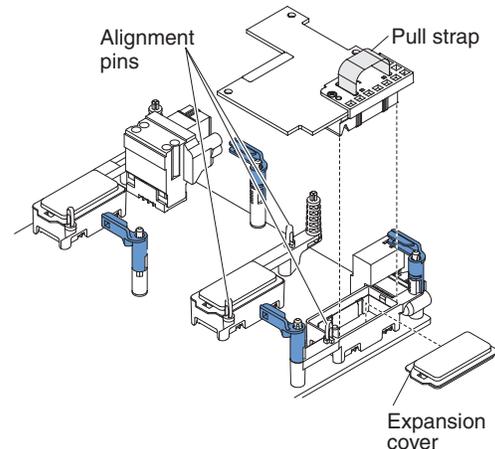
To install an Flex System Manager Network Adapter, complete the following steps:

1. Locate the Flex System Manager Network Adapter connector (see “System-board connectors” on page 10).
2. If an I/O expansion adapter is installed over the Flex System Manager Network Adapter connector, remove it (see “Removing an I/O expansion adapter” on page 455).

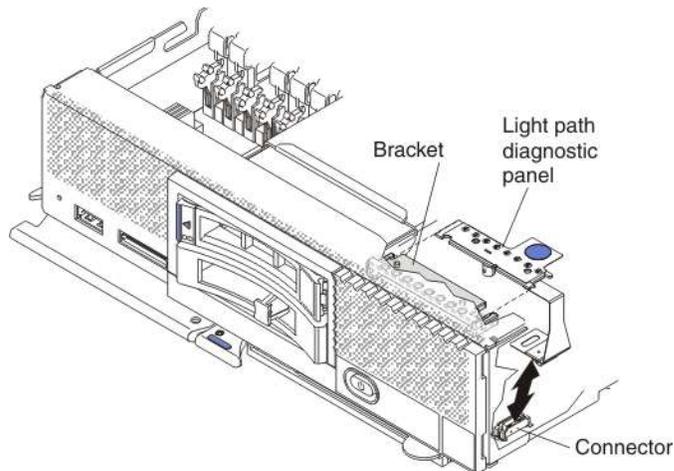
To remove the light path diagnostics panel, complete the following steps.

1. Remove the cover (see “Removing the management node cover” on page 431).
2. Pull the light path diagnostics panel out of the bracket.
3. Disconnect the cable from the system board.
4. Lift the light path diagnostics panel from the node.

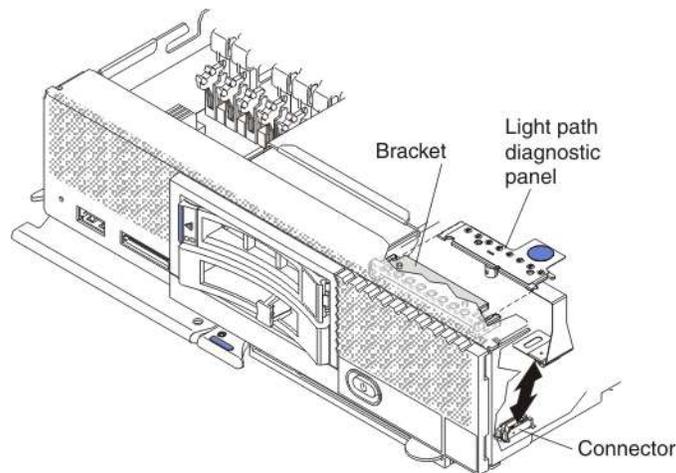
To install a light path diagnostics panel, complete the following steps.

1. Remove the cover (see “Removing the management node cover” on page 431).
2. Connect the cable on the system board.
3. Align the light path diagnostics panel with the bracket.
4. Press the light path diagnostics panel securely in the bracket.

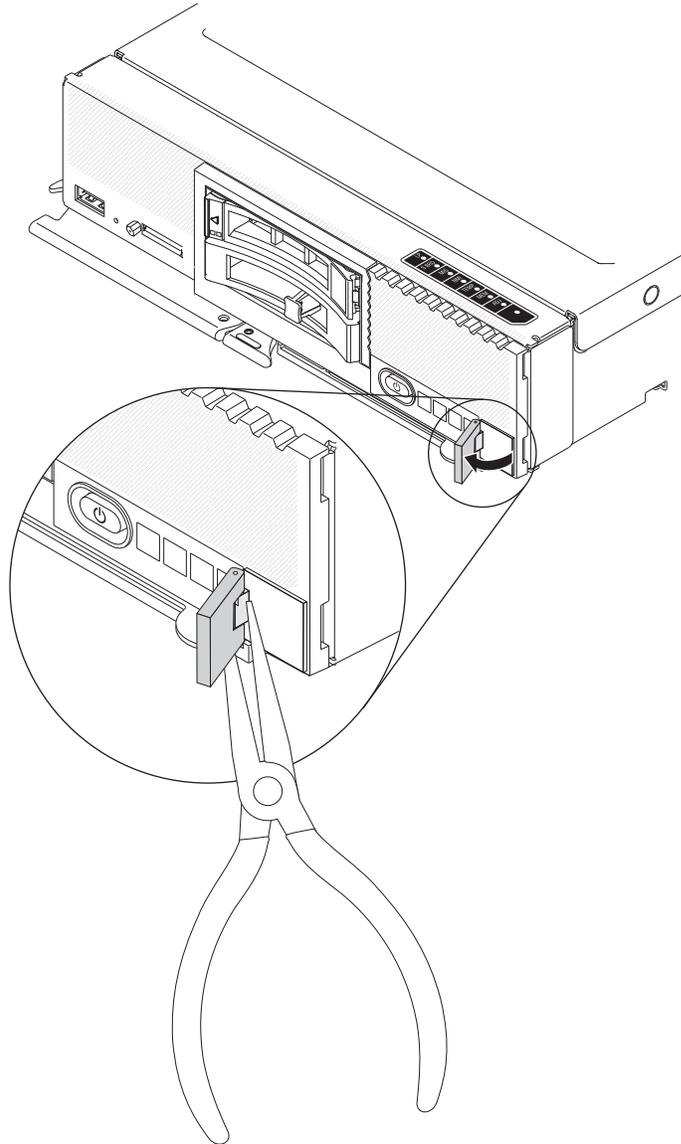
To remove the RFID tag, complete the following steps.

1. If the RFID tag is attached to the hinge, open the RFID tag.
2. Use pliers to carefully grip the hinge and gently pull and twist the base from the bezel.

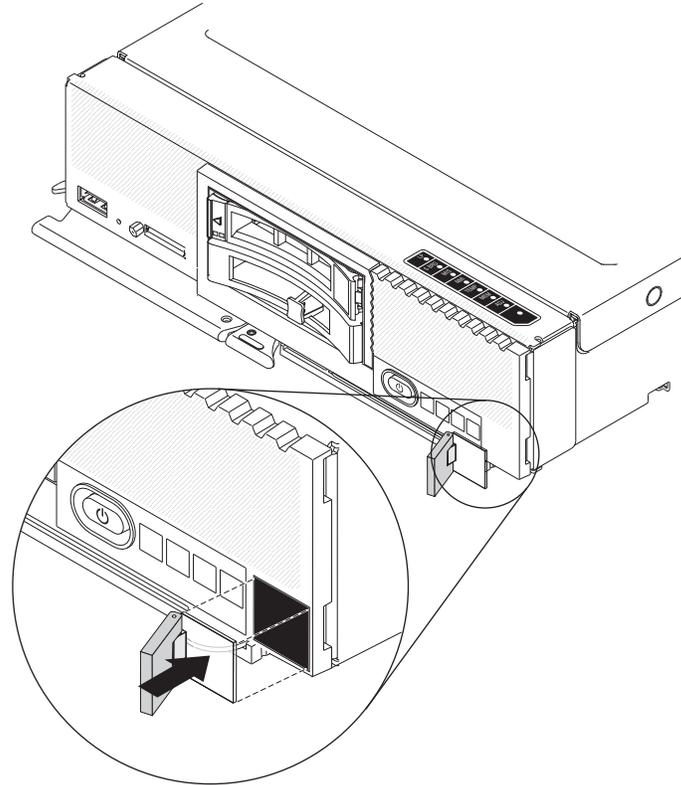
To install the RFID tag, complete the following steps.

1. Make sure that the surface you are installing the tag on is thoroughly clean and dry.
2. Remove the backing from the base to expose the adhesive.
3. Position the RFID tag over the ID label on the front of the bezel.
4. Press the RFID tag securely against the bezel and hold firmly in place for 30 seconds.

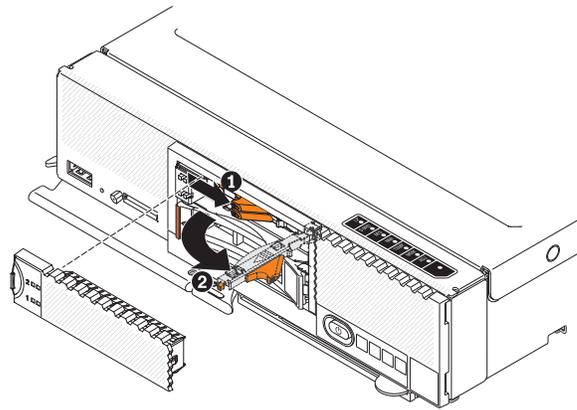
1. Remove the solid state drive bezel from the front of the node.
2. For the solid state drive that you want to remove, press the release latch to the right and rotate the loose end of the retention lever away from the server.

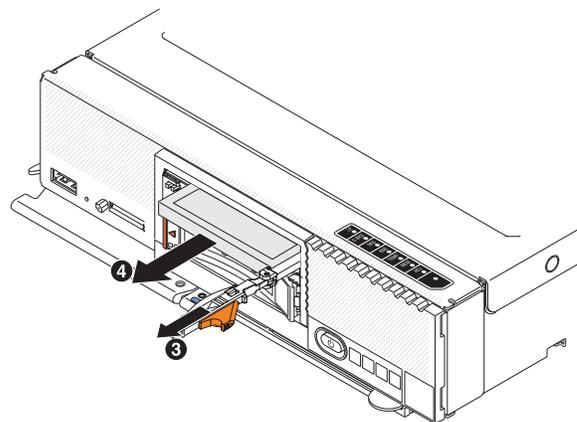
3. Pull the retention lever toward you to slide the solid state drive out of the slot.

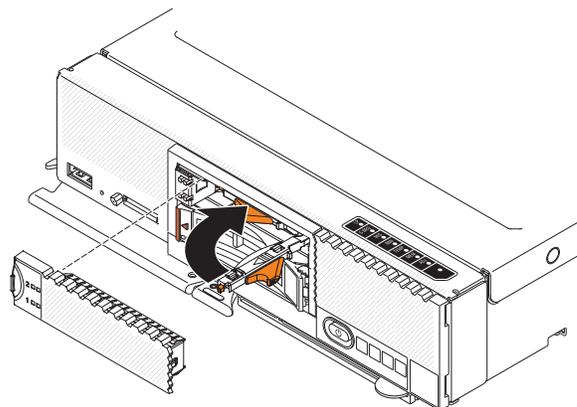
4. Close the retention lever and secure it with the latch.

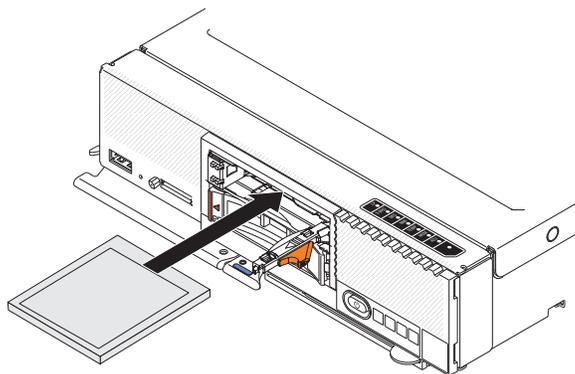
1. Touch the static-protective package that contains the solid state drive to any *unpainted* metal surface on the chassis or any *unpainted* metal surface on any other grounded rack component; then, remove the solid state drive from the package.
2. Slide the solid state drive into the slot until it is firmly seated in the connector.

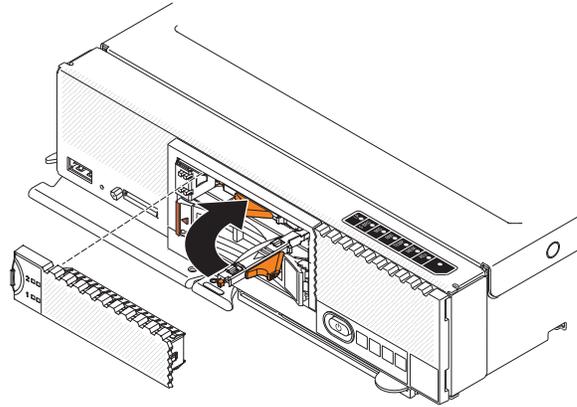
3. If you have a second solid state drive to install, repeat steps 1 through 2.
4. Close the retention lever and secure it with the latch.

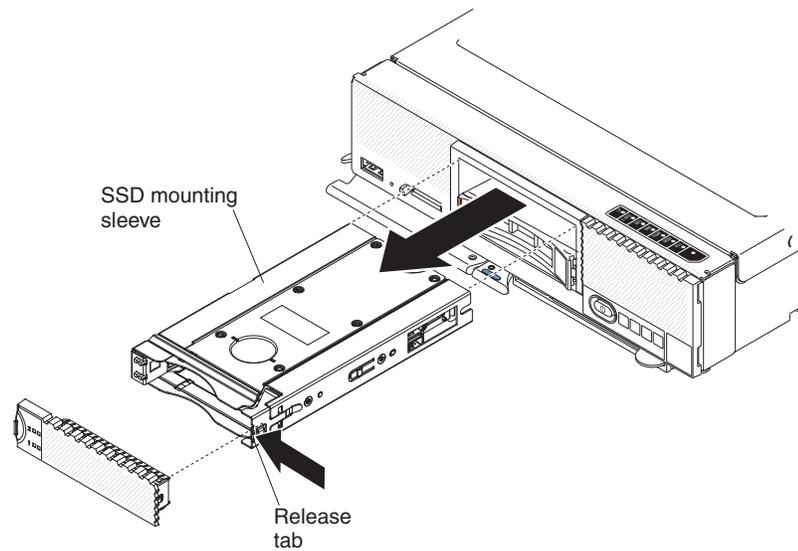
1. Remove the solid state drive bezel.
2. Remove the solid state drives (see “Removing a solid state drive” on page 463).
3. Use a tool, such as a flat screwdriver, to gently pry open the release latch on the right side of the SSD mounting sleeve.
4. Slide the SSD mounting sleeve out of the node.

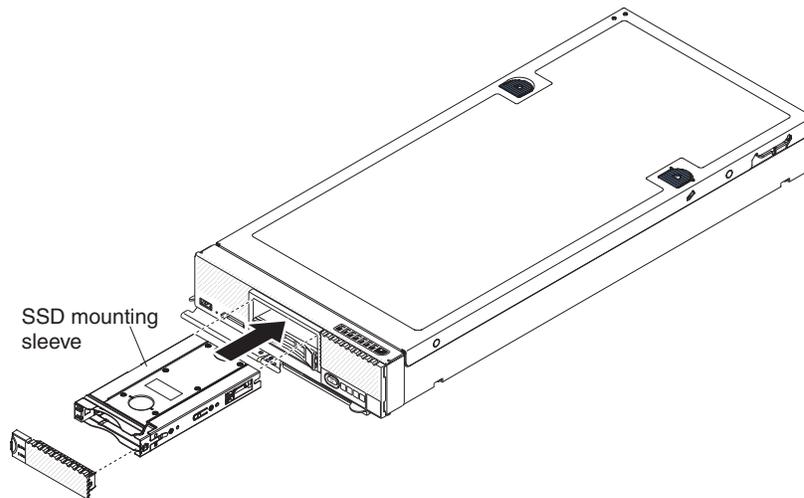
1. If necessary, remove the SSD bezel.
2. Slide the SSD mounting sleeve in the node until the release latch on the right side of the mounting sleeve clicks.
3. Replace the SSDs in the SSD mounting sleeve (see "Installing a solid state drive" on page 465).
4. Replace the SSD bezel.

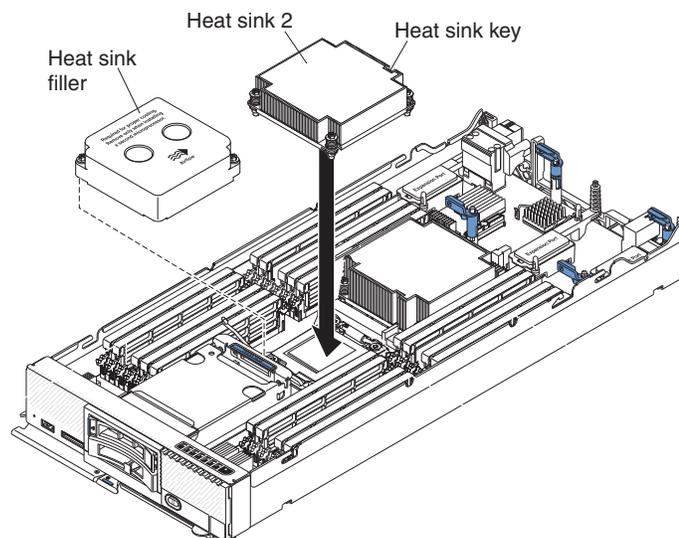
To remove a microprocessor and heat sink, complete the following steps.

1. Remove the cover (see "Removing the management node cover" on page 431).
2. Locate the microprocessor to be removed (see "System-board connectors" on page 10).
3. Remove the heat sink.

- a. Use a screwdriver to loosen the screw on one side of the heat sink to break the seal with the microprocessor.
- b. Use a screwdriver to loosen the screws on the heat sink, rotating each screw two full turns until each screw is loose.
- c. Gently pull the heat sink from the microprocessor.

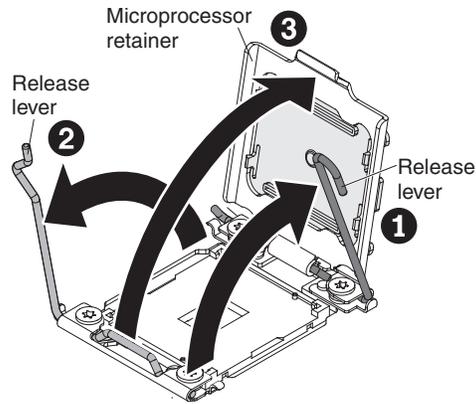
4. Open the microprocessor socket release levers and retainer.

- a. Identify which release lever is labeled as the first release lever to open and open it.
- b. Open the second release lever on the microprocessor socket.
- c. Open the microprocessor retainer.

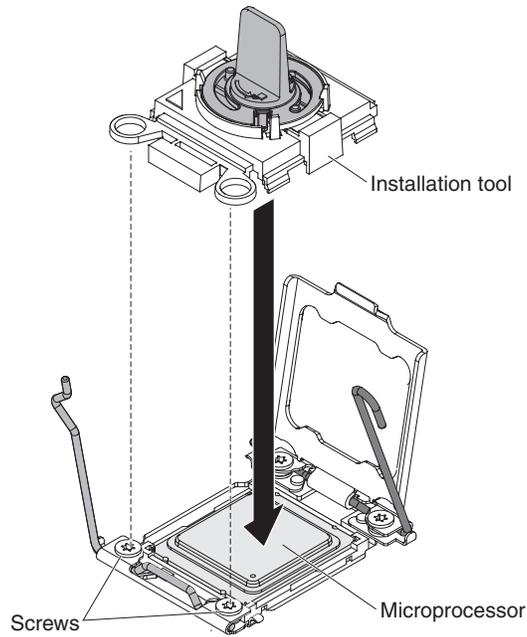
- b. Align the installation tool with the alignment pins on the microprocessor socket and lower the tool on the microprocessor. The installation tool rests flush on the socket only if aligned correctly.
