Flex System Manager Types 7955, 8731, and 8734
Installation and Service Guide

Third Edition (June 2014)

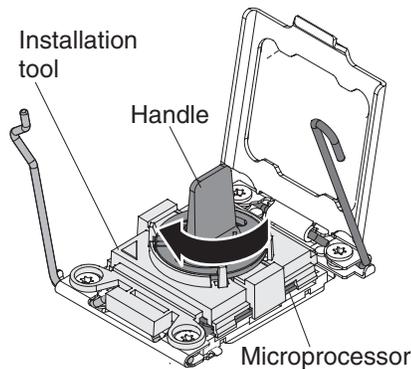
- c. Twist the handle on the installation tool clockwise and lift the microprocessor out of the socket.

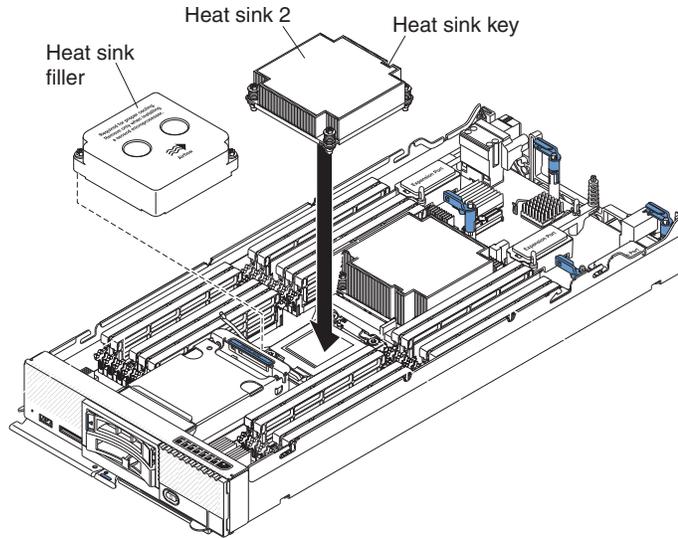
To install a microprocessor and heat sink, complete the following steps.

1. Remove the cover (see “Removing the management node cover” on page 431).
2. Remove the heat-sink filler, if one is present.
3. Open the microprocessor socket release levers and retainer.

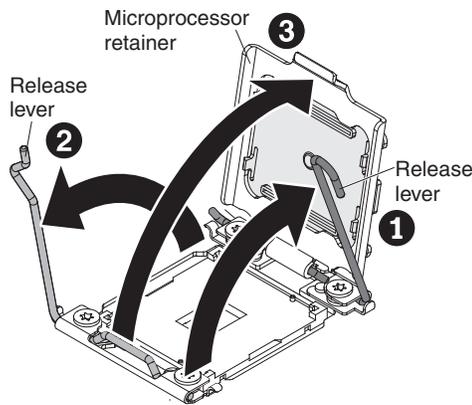
- a. Identify which release lever is labeled as the first release lever to open and open it.
- b. Open the second release lever on the microprocessor socket.
- c. Open the microprocessor retainer.
4. Install the microprocessor on the microprocessor socket:
 - a. Touch the static-protective bag that contains the new microprocessor to any *unpainted* surface on the chassis or any *unpainted* metal surface on any other grounded rack component; then, carefully remove the microprocessor and installation tool from the package.

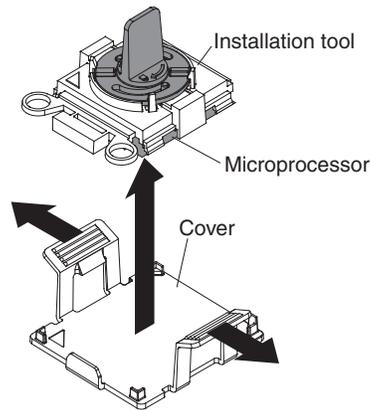
- b. Release the sides of the cover and remove the cover from the installation tool. The microprocessor is preinstalled on the installation tool.

Note: Do not touch the microprocessor contacts. Contaminants on the microprocessor contacts, such as oil from your skin, can cause connection failures between the contacts and the socket.

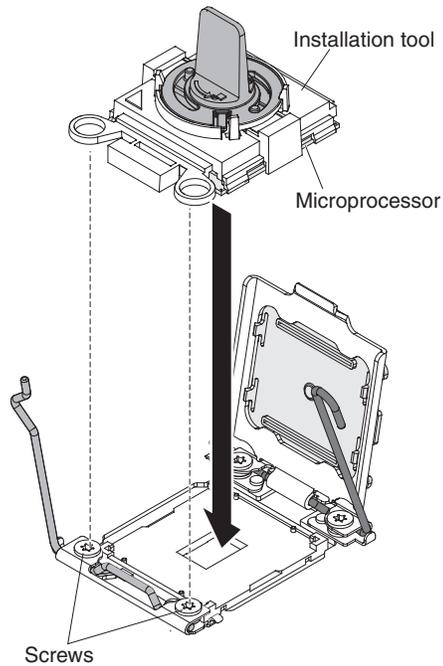
- c. Align the installation tool with the microprocessor socket. The installation tool rests flush on the socket only if it is properly aligned.

- d. Twist the handle on the microprocessor tool counterclockwise to insert the microprocessor into the socket. The microprocessor is keyed to ensure that the microprocessor is installed correctly. The microprocessor rests flush on the socket only if it is properly installed.

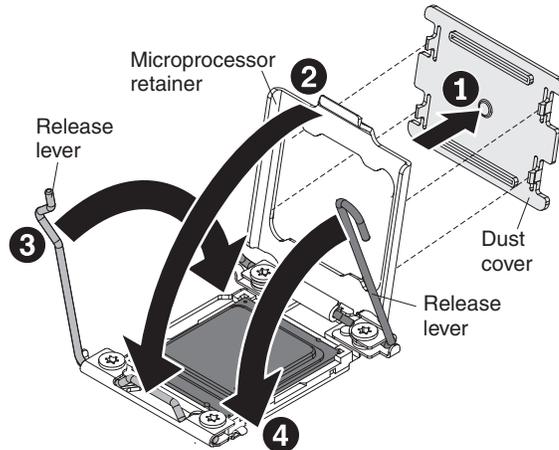
5. Close the microprocessor socket release retainer and levers.

- a. Close the microprocessor retainer on the microprocessor socket.
- b. Identify which release lever is labeled as the first release lever to close, and close it.
- c. Close the second release lever on the microprocessor socket.
- d. If a socket cover is installed over the microprocessor retainer, it is released as you close the retainer. Remove the socket cover from the compute node and store it in a safe place.

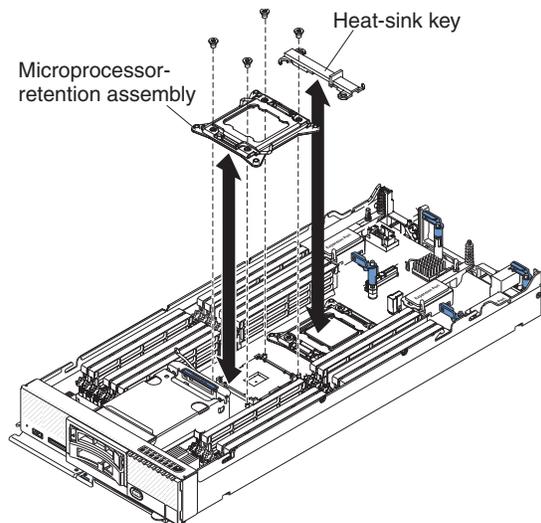
To remove a microprocessor-retention assembly, complete the following steps.

1. Remove the cover (see “Removing the management node cover” on page 431).
2. Locate the microprocessor connector on the system board (see “System-board connectors” on page 10).
3. If a microprocessor and heat sink are installed, remove them (see “Removing a microprocessor and heat sink” on page 468).
4. Remove the heat-sink key from the microprocessor-retention assemblies and store it in a safe place.

- Using a T20 Torx screwdriver, remove the four screws that secure the microprocessor-retention assembly.

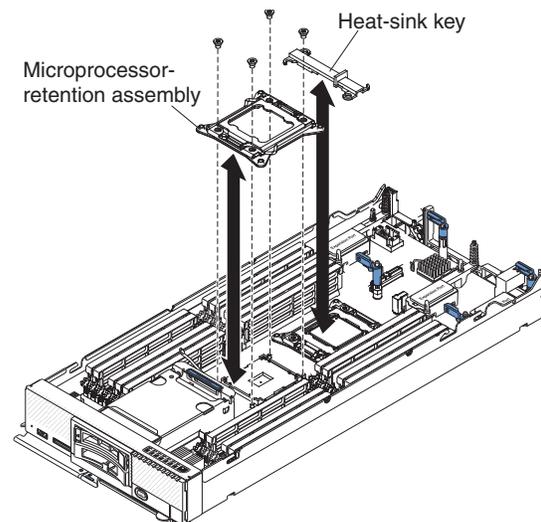
To install a microprocessor-retention assembly, complete the following steps.

- Remove the cover (see “Removing the management node cover” on page 431).
- Make sure that the microprocessor socket release levers are in the open position.

3. Align the microprocessor-retention assembly on the system board.
Attention:
 - a. Do not allow the microprocessor-retention assembly to touch the microprocessor socket. Doing so might result in permanent damage to the system board.
 - b. Do not touch the contacts in the microprocessor socket. Touching these contacts might result in permanent damage to the system board.
4. Using a T20 Torx screwdriver, install the four screws to secure the microprocessor-retention assembly.
5. Install the heat-sink key on the microprocessor retention assemblies.
6. If necessary, install the microprocessor and heat sink (see “Installing a microprocessor and heat sink” on page 471).

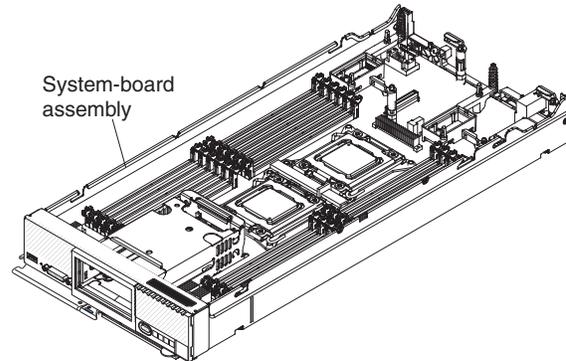
To install the system-board assembly, complete the following steps:

1. Install all of the components in the following list that you removed from the old system-board assembly onto the new system-board assembly.
 - DIMMs and air baffles (see “Installing a DIMM” on page 444).

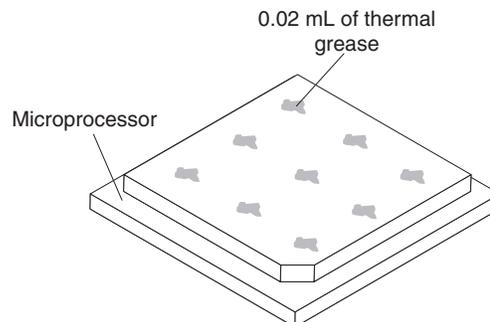
4. Use a clean area of the cleaning pad to wipe the thermal grease from the microprocessor; then, dispose of the cleaning pad after all of the thermal grease is removed.

5. Use the thermal-grease syringe to place nine uniformly spaced dots of 0.02 mL each on the top of the microprocessor.

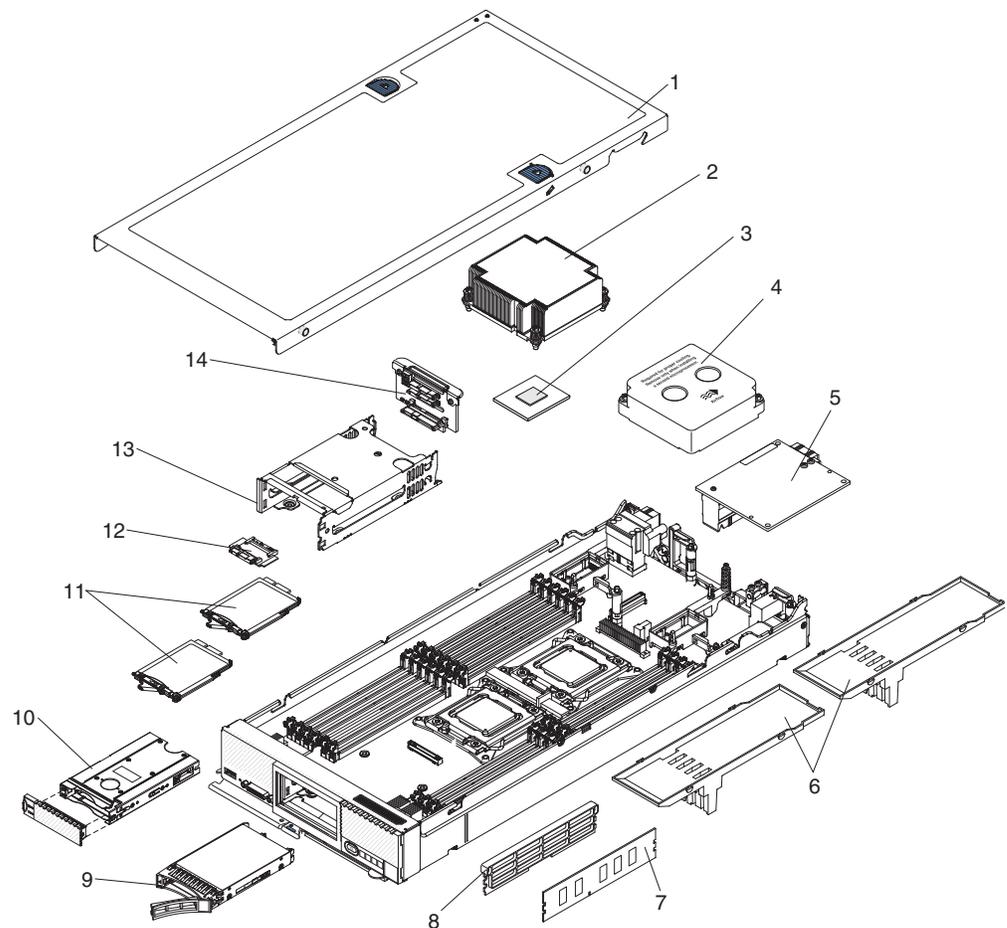
Note: The illustrations in this document might differ slightly from your hardware.

Replaceable management node components
